# 15 storage tanks repaired in a refinery

ID: 9440

**Industry:** Chemical & Petrochemical  
**Application:** TCC-Tanks and Chemical Containment Areas  
**Substrate:** Other  
**Products:** Belzona 3211 (Lagseal), Belzona 3921 (GSC Surface Conditioner)

**Customer Location:** Spain  
**Application Date:**

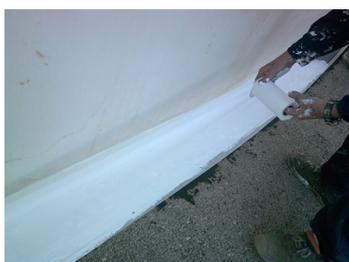
The client was experiencing a problem with 15 storage tanks where the base was in very poor condition, resulting in water ingress and requiring a new encapsulation.

Tank base after the Belzona 3211 application.

The application procedure of Belzona 3211 membrane has been common for all 15 tanks and followed the recommendations of the Belzona GSS3 System.

First both the surface and the base of the tank were cleaned with solvent to remove any remaining grease. As the refinery is an ATEX area, wire brushes have been used for areas more severely affected by corrosion. Then, Belzona 3921 conditioner was applied. Where a very large unevenness was observed at the transition between the tank and the floor, expansion foam was applied. Next Belzona 9431 tape was placed at the metal-concrete transition to absorb tank movements, followed by the application of the first layer of Belzona 3211, then reinforcing sheet, and in the overcoat window the second layer of Belzona 3211. A visual inspection of the application was carried out around the entire perimeter of the tank.
