# Concrete Repair in Wastewater Clarifier

ID: 9442

Application: TCC-Tanks and Chemical Containment Areas

Products: Belzona 4131 (Magma-Screed), Belzona 4911 (Magma TX Conditioner)

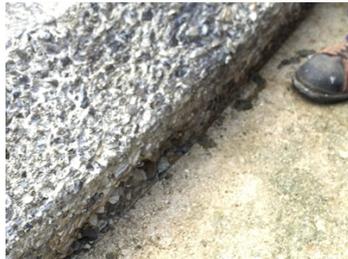
Constant water running over the weirs has caused damage to the concrete

Damage after it was cleaned.

Clarifier was pressure washed and any loose concrete was removed Belzona 4131 and conditioner was applied according to IFU.

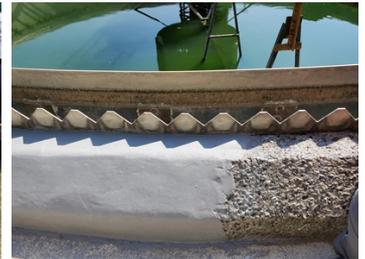
Applying Belzona 4131

Before and after.
