Chemical Containment Area

ID: 9443

Industry: Chemical & Petrochemical
Application: TCC-Tanks and Chemical Containment Areas
Substrate: Concrete
Products: Belzona 4311 (Magma CR1), Belzona 4911 (Magma TX Conditioner)

Customer Location: GA
Application Date: May 2024

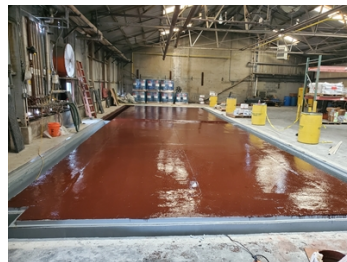
The first coat of Belzona 4311

The new concrete was over 30 days old. It was pressure washed and allowed to dry then a grinder was used to give a profile on the concrete, It was cleaned again to remove the dust. Belzona 4911 primer was applied, then Belzona 4311 second coat of Belzona 4311 Grey followed Red.

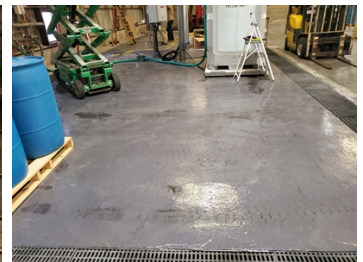
Follow up picture
