# Belzona 1212 Stops The Leaking Pan

**Industry:** Heating, Ventilation & Air Conditioning  
**Application:** HEX-Heat Exchangers  
**Substrate:** Stainless-steel  
**Products:** Belzona 1212

**Customer Location:** Tulsa Oklahoma  
**Application Date:** June 2024

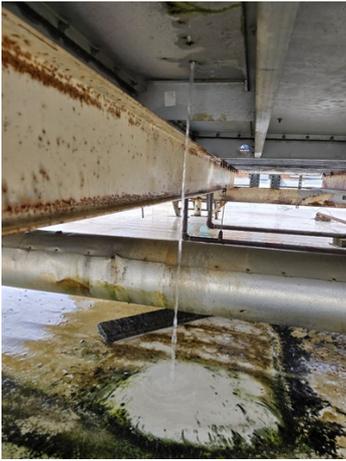
The water pan on their air handler developed a series of holes with the largest one about 3/4" in size and were losing gallons of water by the minute.

The constant stream of water leaking from the largest hole.

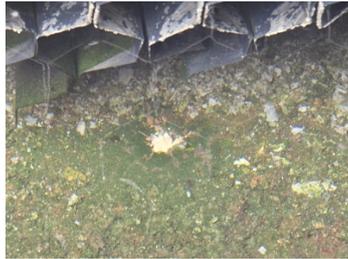
The hole from the top side of the pan.

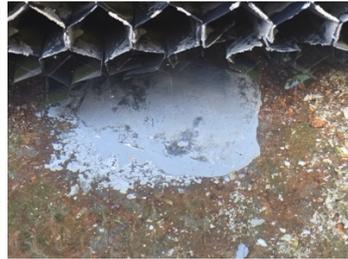
The large hole covered with Belzona 1212 and some reinforcement metal.

Coarse alumina oxide wet/dry sandpaper was used to prep the surface and remove the corrosion as the application area was under 8" of water. The reinforcement metal was roughened and cleaned, and a liberal amount of Belzona 1212 was applied to both the surface of the pan and the plate. The plate was then pushed firmly into place until excess material had appeared from all sides showing that full contact was achieved.

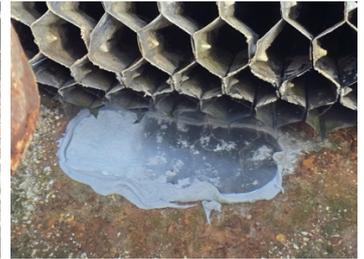
This Belzona 1212 and reinforcement metal is covering about 6" of moderate size pinholes.
