Belzona 1212 Stops The Leaking Pan

ID: 9446

Industry: Heating, Ventilation & Air Conditioning
Application: HEX-Heat Exchangers
Substrate: Stainless-steel
Products: Belzona 1212

Customer Location: Tulsa Oklahoma
Application Date: June 2024

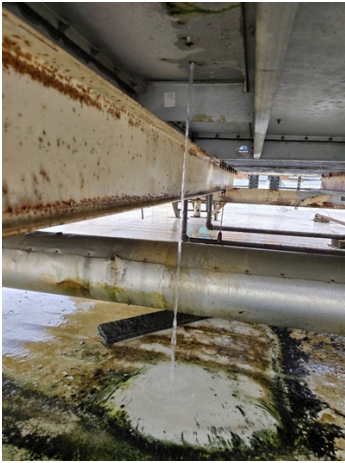
The water pan on their air handler developed a series of holes with the largest one about 3/4" in size and were losing gallons of water by the minute.

The constant stream of water leaking from the largest hole.

Coarse alumina oxide wet/dry sandpaper was used to prep the surface and remove the corrosion as the application area was under 8" of water. The reinforcement metal was roughened and cleaned, and a liberal amount of Belzona 1212 was applied to both the surface of the pan and the plate. The plate was then pushed firmly into place until excess material had appeared from all sides showing that full contact was achieved.

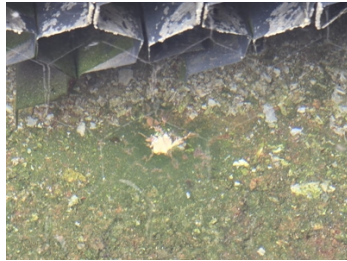
The hole from the top side of the pan.

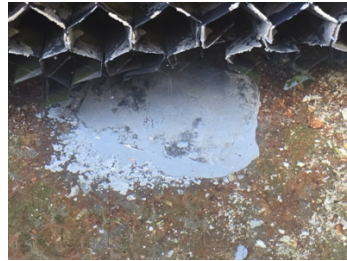
The large hole covered with Belzona 1212 and some reinforcement metal.

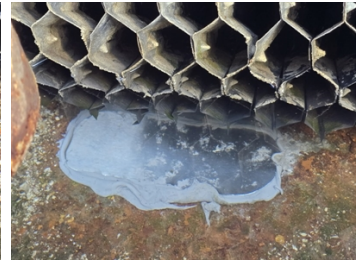
This Belzona 1212 and reinforcement metal is covering about 6" of moderate size pinholes.
