Belzona 3121 Keeps the ER Entrance Dry

Industry: *Buildings & Structures*
Application: *RPA-Roof Problem Areas*
Substrate: *Masonry*
Products: *Belzona 3121 (MR7)*

Customer Location: *Tulsa Oklahoma*
Application Date: *July 2024*

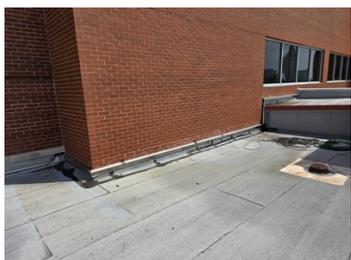
Original condition of the roof showing where other roof repair materials had been applied that failed.

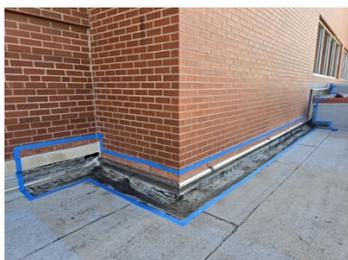
The repair area cleaned, prepped, and taped off.

Sanding disks were used on a grinder to prep the roofing material and metal flashing with careful inspection to ensure the substrate was solid with no loose sections. The brick was prepped with a masonry grinding disk. The first coat of Belzona 3121 was applied with care to get into all of the crevices and seams. Belzona 9331 reinforcement sheet was embedded into the first layer, and then overcoated with a second coat of Belzona 3121.

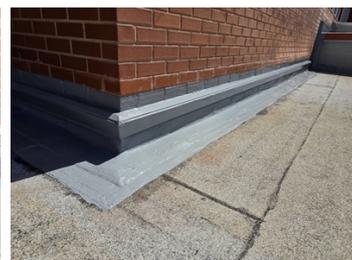
Completed application.
