# Belzona 3121 Keeps the ER Entrance Dry

Industry: *Buildings & Structures*  
Application: *RPA-Roof Problem Areas*  
Substrate: *Masonry*  
Products: *Belzona 3121 (MR7)*

Customer Location: *Tulsa Oklahoma*  
Application Date: *July 2024*

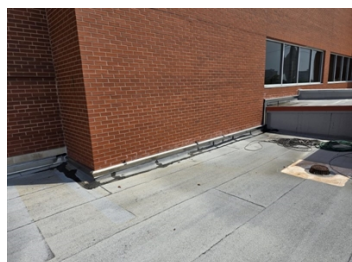
*Leaks in the roof over the entrance of the ER was getting paramedics and patients wet when it was raining.*

Original condition of the roof showing where other roof repair materials had been applied that failed.

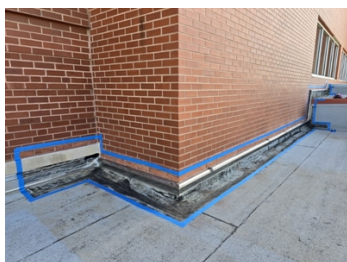
The repair area cleaned, prepped, and taped off.

Sanding disks were used on a grinder to prep the roofing material and metal flashing with careful inspection to ensure the substrate was solid with no loose sections. The brick was prepped with a masonry grinding disk. The first coat of Belzona 3121 was applied with care to get into all of the crevices and seams. Belzona 9331 reinforcement sheet was embedded into the first layer, and then overcoated with a second coat of Belzona 3121.

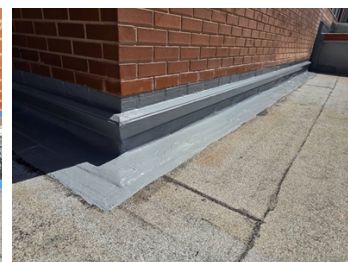
Completed application.
