Belzona Salvages an Aquarium Pump Intake

Application: PDP-Positive Displacement Pumps

Substrate: Cast Iron

Products: Belzona 1111 (Super Metal), Belzona 1341N (Supermetalglide)

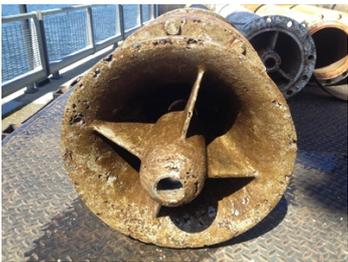
This salt water intake pump had heavy erosion, suspected to be caused by galvanic corrosion.

Original condition when removed from the salt water.

Due to the severe erosion on this salt water pump intake, the aquarium was debating on replacing this pump. After carefully researching to verify that Belzona 1111 and Belzona 1341N would not impact the marine life in the aquarium, the decision was made to rebuild the pump, and protect it with Belzona 1341N.

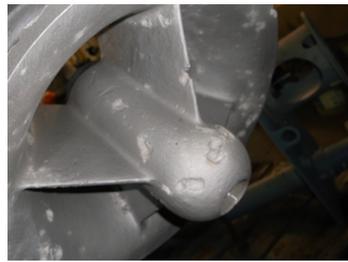
Grit blasted and ready for Belzona 1111.

Grit blasting was used to remove all surface contamination and prepare the surface according to the Instructions For Use for both Belzona 1111 and Belzona 1341N. The Belzona 1111 was applied with Belzona applicators and allowed to cure, then hand sanded to achieve a smooth profile. The piece was then lightly grit blasted again prior to the application of the Belzona 1341N by brush.

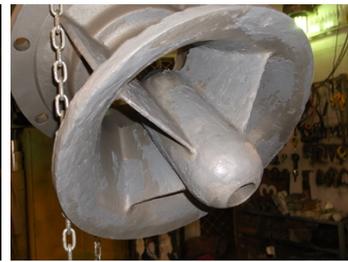
Belzona 1111 applied.

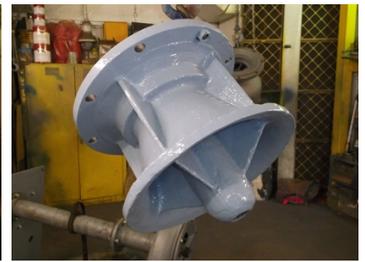
Protected with two coats of Belzona 1341N.

The cost to repair this pump was considerably less expensive than replacing it, plus the with the operating condition of the pump, the lengthy lead time for a new pump was unacceptable. Even with the amount of Belzona 1111 needed to rebuild the damage, the repair was still roughly half the cost of replacement, and the replacement would not have had an efficiency enhancing protective coating applied to it. Upon completion, the aquarium repeated the application on the other two intake pumps as well. An inspection of the pump three years later showed no erosion or damage, and less than usual marine life attached to the pump as Belzona 1341N is very smooth and made it difficult for the usual barnacles and mussels to attach themselves.
