# Belzona 1111 and 1341N Repair the Spiders

Application: *PDP-Positive Displacement Pumps*

*Heavy erosion to the spiders that support the shaft on a vertical multi-stage pump.*

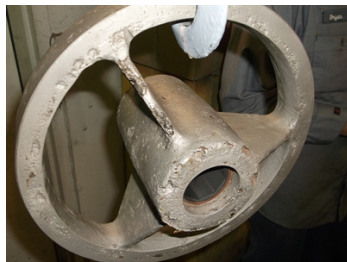
Original condition.

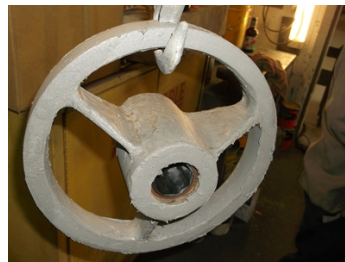
Grit blasted and ready for rebuilding.

The pieces were grit blasted and solvent washed, then Belzona 1111 applied to all of the eroded areas by hand using a Belzona applicator. Once the Belzona 1111 was cured, the pieces were sanded and shaped by hand, and then coated with two 10 mil coats of Belzona 1341N.
