# Belzona 1111 and 1341N Repair the Spiders

Application: *PDP-Positive Displacement Pumps*

*Heavy erosion to the spiders that support the shaft on a vertical multi-stage pump.*

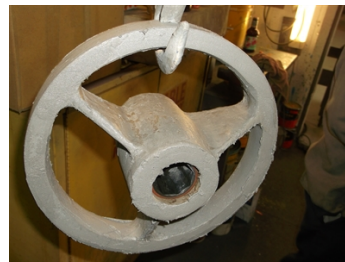
Grit blasted and ready for rebuilding.

The pieces were grit blasted and solvent washed, then Belzona 1111 applied to all of the eroded areas by hand using a Belzona applicator. Once the Belzona 1111 was cured, the pieces were sanded and shaped by hand, and then coated with two 10 mil coats of Belzona 1341N.
