# Belzona 1111 Can Rebuild Severe Pump Corrosion

*Heavy metal loss on the internal components of a multi-stage vertical salt water pump.*

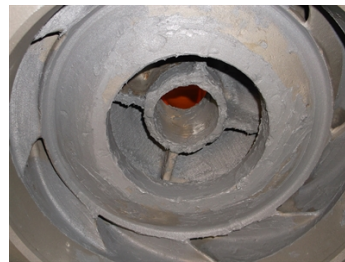
Up close view of the damage.

Deep pitting on the internal parts were causing poor performance with this pump.

Grit blasting to prepare the surface according to the Belzona 1111 Instructions For Use. Then the Belzona 1111 was applied by hand using the Belzona applicator. Once cured, the application was hand sanded to the original profile and coated with two full coats of Belzona 1341N.

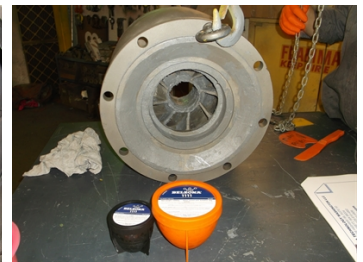
Belzona 1111 filling in all of the damage and correcting the profile.
