Belzona 1111 Can Rebuild Severe Pump Corrosion

Application: *PDP-Positive Displacement Pumps*

Heavy metal loss on the internal components of a multi-stage vertical salt water pump.

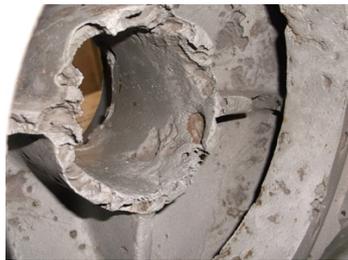
Original condition after opening the pump.

Deep pitting on the internal parts were causing poor performance with this pump.

Grit blasting to prepare the surface according to the Belzona 1111 Instructions For Use. Then the Belzona 1111 was applied by hand using the Belzona applicator. Once cured, the application was hand sanded to the original profile and coated with two full coats of Belzona 1341N.

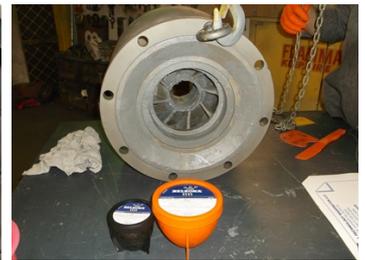
Belzona 1111 filling in all of the damage and correcting the profile.
