Belzona 1111 keeps the 210' Cutter safe.

ID: 9452

Application: SOS-Ships and Offshore Structures

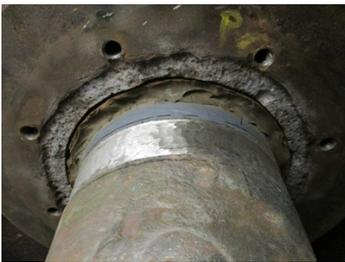
The shaft and gasket seal face were eroded from salt water corrosion on both propulsion shafts.

Showing the area of damage to the shaft and gasket surface prepped.

The shaft was prepped with a hand grinder removing roughly 1/4" of damaged shaft to allow for a decent bed of Belzona 1111. The gasket surface was hand prepped using an MBX Bristleblaster since the damage was fairly deep. Belzona 9411 was liberally applied to the formers in two coats to ensure a good release. Belzona 1111 was applied with a short bristle brush to the application area, and then to both surfaces in thin layers to avoid any air pockets. The formers were then put in place and tightened down being sure that excess Belzona 1111 squeezed out from all sides. Once the Belzona 1111 was cured, the formers were carefully removed, and the application areas dressed down with emery cloth on the shafts and hand sanding blocks on the gasket surface.

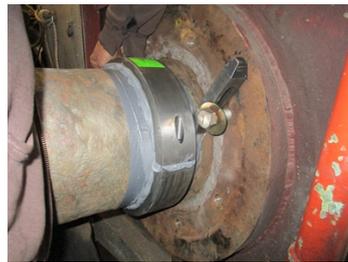
The shaft former in place showing the excess Belzona 1111 squeezing out.

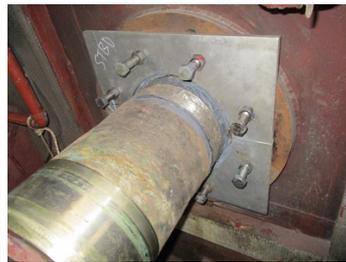
The gasket area former in place with Belzona 1111.

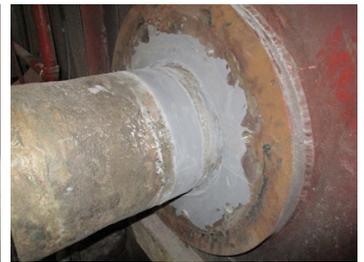
Application complete showing the initial clean up.
