Belzona Protects Against Impeller Wear

ID: 9453

Application: CEP-Centrifugal Pumps

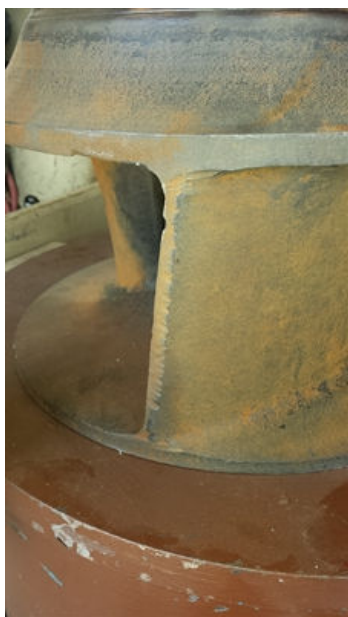
This wastewater impeller was suffering from abrasive wear.

Showing some of the wear.

This impeller was showing the early stages of abrasive wear from wastewater solids. The customer wanted to repair the damage, and protect it from further damage. For only a couple hundred USD, this impeller was protected and returned to service in two days.

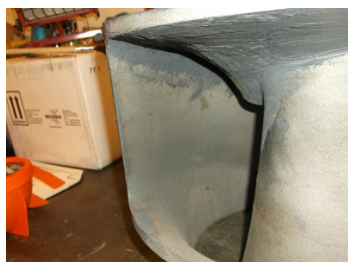
Belzona 1311 applied.

The impeller was grit blasted in the customers blasting booth and rinsed of with acetone solvent before applying the Belzona 1311. Once the Belzona 1311 was firm enough, the first coat of Belzona 1321 was applied, and after a couple hours (per the Instructions For Use) the customer applied the second coat of Belzona 1321.

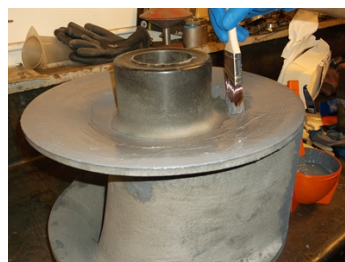
Applying the first coat of Belzona 1321.

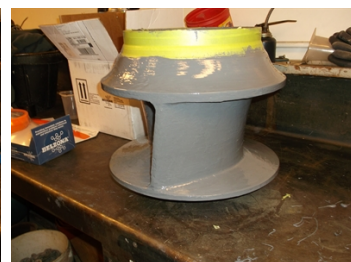
First coat of Belzona 1321 complete.
