Belzona Protects Against Impeller Wear

ID: 9453

Application: CEP-Centrifugal Pumps

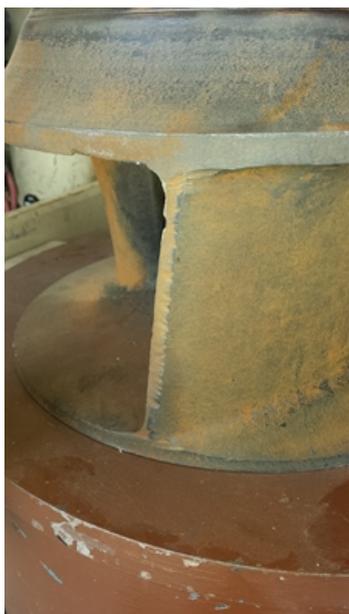
This wastewater impeller was suffering from abrasive wear.

Showing some of the wear.

This impeller was showing the early stages of abrasive wear from wastewater solids. The customer wanted to repair the damage, and protect it from further damage. For only a couple hundred USD, this impeller was protected and returned to service in two days.

The impeller was grit blasted in the customers blasting booth and rinsed of with acetone solvent before applying the Belzona 1311. Once the Belzona 1311 was firm enough, the first coat of Belzona 1321 was applied, and after a couple hours (per the Instructions For Use) the customer applied the second coat of Belzona 1321.

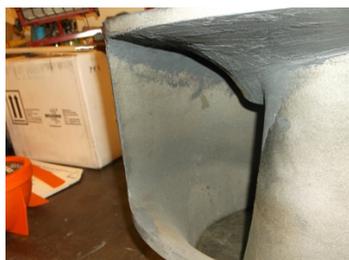
Belzona 1311 applied.

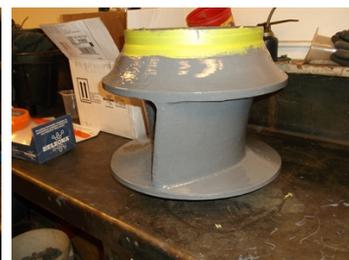
Applying the first coat of Belzona 1321.
