Belzona 4111 Refurbishes the Ball Mill Ends

Industry: *Mining & Quarrying*
Application: *SHM-Solids Handling Machinery*

Substrate: *Cast Iron*
Products: *Belzona 4111 (Magma-Quartz), Belzona 4911 (Magma TX Conditioner)*

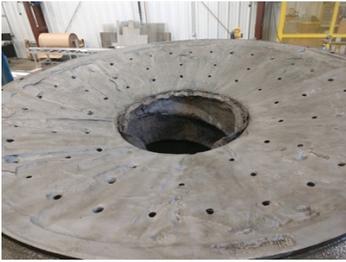
The ball mill ends had heavy wear and erosion.

Showing the damage to the surface.

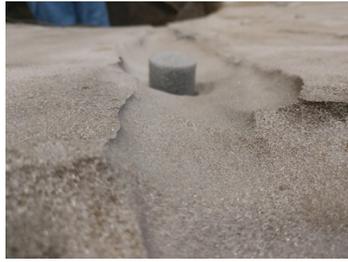
Backer rods inserted into the wear plate mounting holes and showing the target profile height.

The surface was grit blasted and solvent washed. The Belzona 4111 was applied by trowel and hand, pushing it firmly into the uneven surface, and checked for the proper finish using an aluminum straight edge.

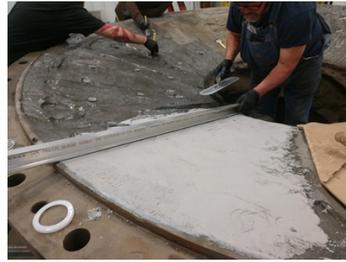
Applying Belzona 4911 Conditioner in the background, and applying Belzona 4111 using a guide to achieve the proper profile.
