# Belzona 4111 Makes For A Smooth Floor

ID: 9455

**Application:** FPA-Floor Problem Areas

**Substrate:** Concrete

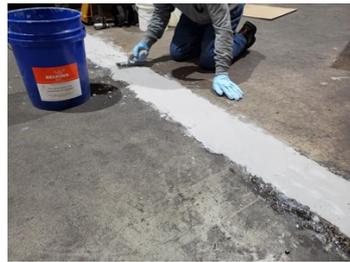
One of the damaged areas in a doorway.

The damaged concrete areas were prepped with a hand grinder and wire wheel to remove all loose material and roughen the surface. The Belzona 4911 conditioner was applied with a short bristled brush, and the Belzona 4111 was applied by hand, pushed firmly into the repair areas, and finished with a steel trowel.

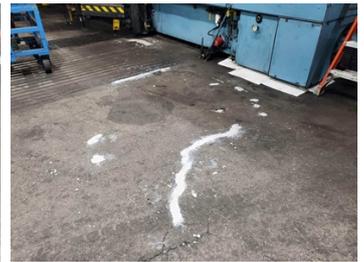
Showing several areas of damage near a machine.

Several damaged areas repaired.
