# Belzona 4111 Makes For A Smooth Floor

ID: 9455

**Application:** FPA-Floor Problem Areas

**Substrate:** Concrete

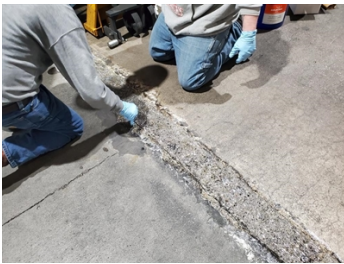
*This older metal casting facility had a lot of damaged areas on their concrete floor.*

One of the damaged areas in a doorway.

The damaged concrete areas were prepped with a hand grinder and wire wheel to remove all loose material and roughen the surface. The Belzona 4911 conditioner was applied with a short bristled brush, and the Belzona 4111 was applied by hand, pushed firmly into the repair areas, and finished with a steel trowel.

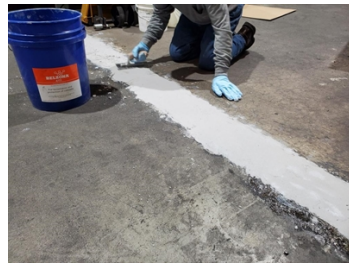
Damaged doorway area repaired.

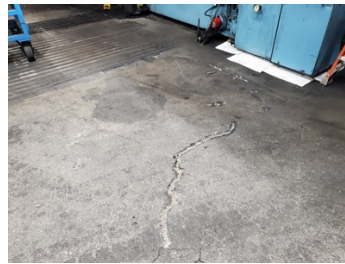
Showing several areas of damage near a machine.

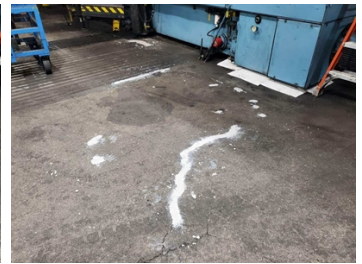
Several damaged areas repaired.
