# Belzona 1111 Fixes Pitting on a Wicket Gate

Industry: *Power*  
 Application: *CEP-Centrifugal Pumps*  
 Substrate: *Carbon steel*  
 Products: *Belzona 1111 (Super Metal)*

Customer Location: *Washington*  
 Application Date: *January 2017*

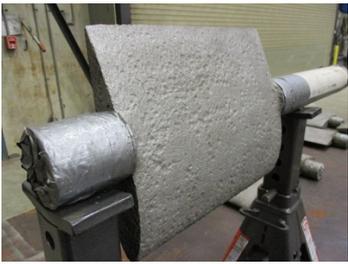
*Full spread corrosion and erosion on the body of these wicket gates.*

Pitting on the face.

Heavy widespread pitting on all surfaces of these wicket gates needed to be repaired. Belzona 1111 was chosen for its ability to be mixed in smaller amounts as needed, its working life, and being 100% solids that would not shrink, and was 100% machinable once cured. The added bonus was no bad chemical smells which made for a pleasant application.

The customer had a nice sand blasting booth on-site, and were able to use alumina oxide to achieve a 3-5 mil profile. Once blasted, they were washed with acetone, and the Belzona 1111 carefully was applied by hand leaving very little to be hand sanded once it had cured.

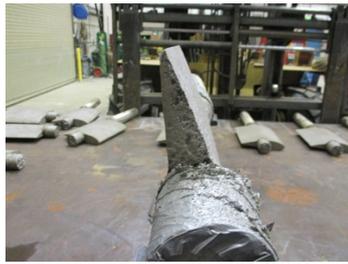
Pitting on the end.

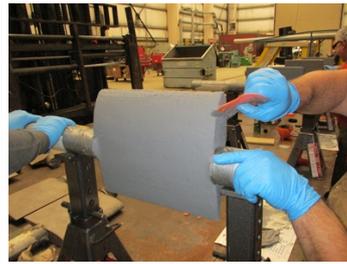
Applying the Belzona 1111.

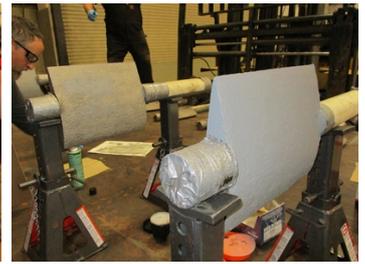
Application completed on this wicket gate.

Welding had been their previous solution, but they chose to use Belzona 1111 because of a faster return to service, and no unnecessary heat stress would occur. All 12 wicket gates were rebuilt, and sanded smooth in one day allowing for the finish coat to be applied the following day. Welding would have taken over a week. Prior to involving Belzona, a coating had already been purchased to coat the gates with. Inspection one year later showed some wear on the coating, but no wear on the Belzona 1111.
