Belzona Helps Make Quality Chips

Industry: *Pulp & Paper*
 Application: *SHM-Solids Handling Machinery*

Substrate: *Carbon steel*
 Products: *Belzona 1811 (Ceramic Carbide)*

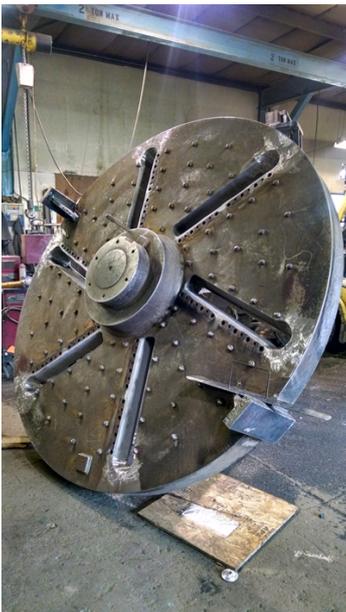
The pockets where the chipper knives are mounted were wearing out.

The chipper disk.

The pockets located behind the chipper knives wears back over time. This creates irregular wood chips, which in turn lowers the quality of the chips that the paper mills purchase. Applying Belzona 1811 to protect against the wear lengthens the life of the blade and allows the mill to produce consistent high quality wood chips.

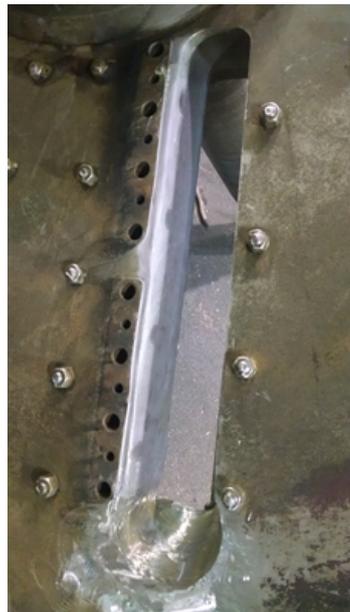
One of the pockets ready for application.

The application surface was prepped by grit blasting, solvent washed, and the Belzona 1811 was applied using the mixing knife, applicator, and by hand. Once the material was firm enough, the surface was smoothed down by hand using soapy water, creating a fine smooth finish.

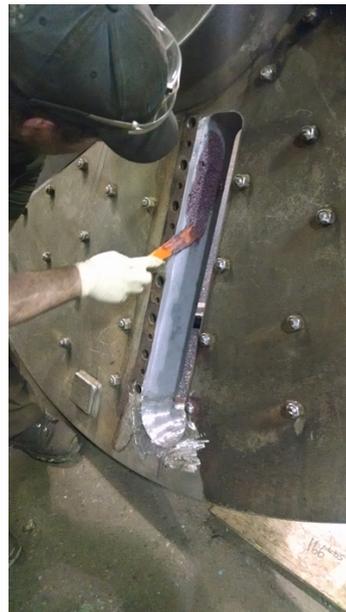
Starting the application.

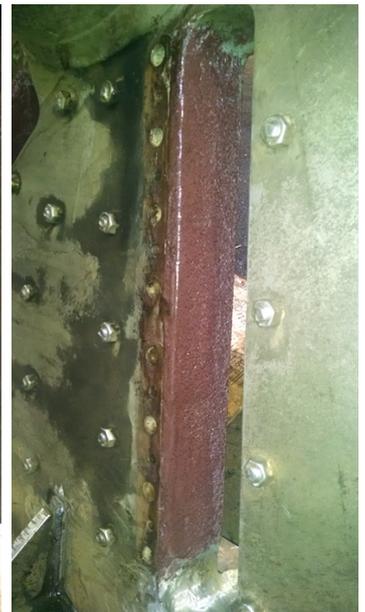
Application completed.

Regular inspections showed minimal wear of the Belzona 1811, much less than the original steel had, and did not require any further attention for 4 years. At that time, as a preventative measure, some additional Belzona 1811 was added to the original material applied in 2015.
