Belzona 1111 Machined Shaft Repair

ID: 9458

Industry: *Marine*
Application: *MPT-Mechanical Power Transmission*

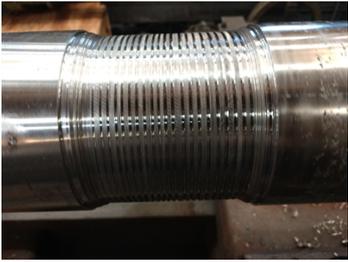
Shaft is mounted on a lathe, and the area has been machined down and roughened, ready for the application.

The propulsion shaft on a small fishing vessel had some corrosion in the area where the seal mounts.

There was some corrosion located on the propulsion shaft on this small fishing vessel. The damage was located where the seal is mounted that keeps the sea water on the outside of the vessel. Failure of the surface here would eventually lead to a failure of the seal and would result in water leaking into the vessel. Using Belzona 1111 allowed for a repair to take place inside of one day, and allowed the vessel to be put back together sooner and returned to service without additional cost of extended dry-dock fees.

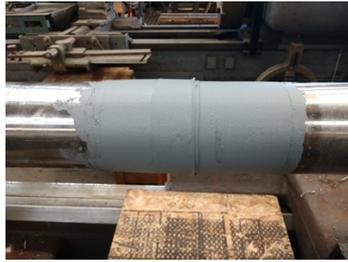
Belzona 1111 applied while the lathe was turning slowly.

A lathe was used to prep the area, as well as to remove the excess Belzona 1111. When the Belzona 1111 was applied, it was applied with the lathe turning slowly using a short bristled brush, first scrubbing the material into the roughened surface, and then slowly applying thin layers until the application area was filled out beyond the diameter of the shaft. Applying it in this manner helps to avoid air pockets which result in voids that need to be filled once the shaft is machined down. Should any voids appear during the machining process, additional Belzona 1111 is applied to fill them, allowed to cure, and machined again to the final dimensions.

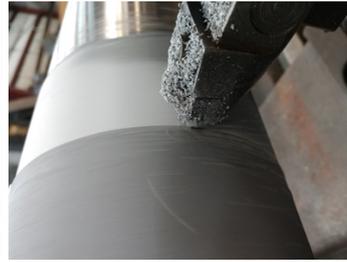
Machining the Belzona 1111 to the proper dimension.

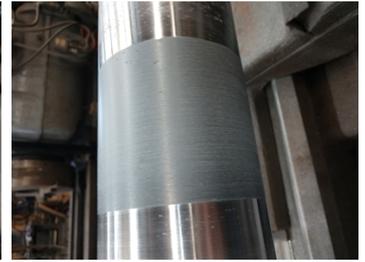
Application completed, fully machined, and dressed down with emery cloth.
