# Belzona Rebuilds and Protects an Outboard

Industry: Marine  
Application: ENC-Engines and Casings  
Substrate: Cast Iron  
Products: Belzona 1111 (Super Metal), Belzona 1341 (Supermetalglide)

Customer Location: Washington  
Application Date: May 2019

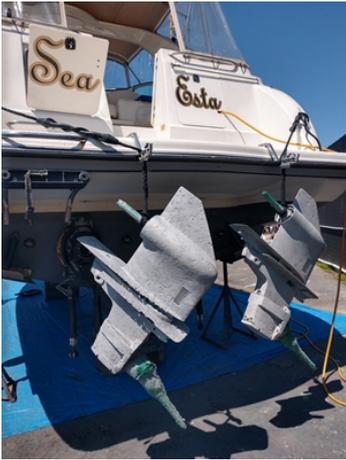
Salt water had corroded this outdrive.

The application areas were grit blasted and washed to remove the salt water. Belzona 1111 was applied by applicator to rebuild the missing areas and smooth out the pitting. Once firm, Belzona 1341 was applied in two coats to prevent further damage.

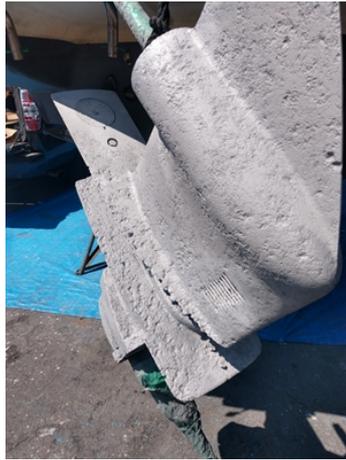
Both outdrives sandblasted and ready for application.

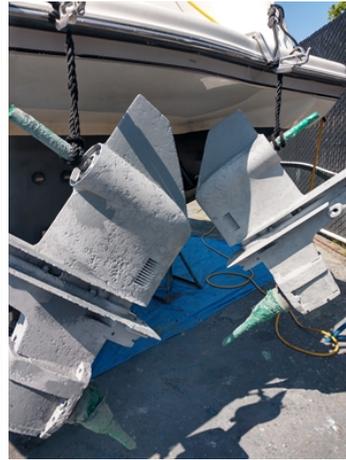
Up close, showing the erosion damage.

The original coating had failed and allowed the salt water to penetrate and corrode the casings on these yacht outboard drives. The options were to either repair them or replace them. Both units were rebuilt, and protected for under \$2000 USD which would not even bought one replacement outdrive for this yacht.
