# Belzona 1341 refurbishes a spiral casing on a Francis turbine

ID: 9462

Customer Location: Wales  
Application Date: June 2024

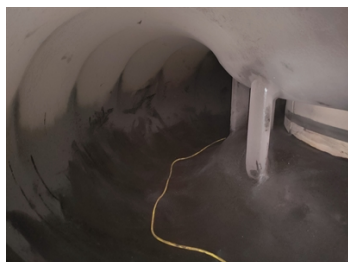
Spiral casing was grit blasted back to profile, using 2.5 tons of grit.

The project involved working in confined spaces with limited access, using 2.5 tons of grit to remove the old lining and achieve the correct profile and cleanliness.

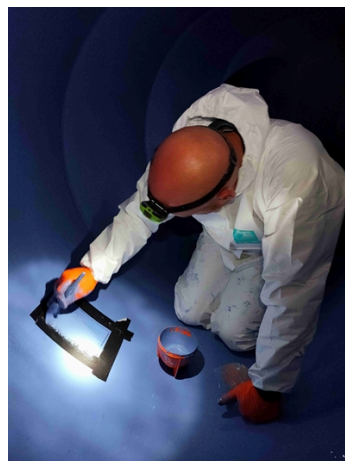
Belzona 1111 was used to reprofile heavily pitted areas prior to coating of Belzona 1341 (Supermetalglide)

Reprofiling was conducted on heavily corroded areas using Belzona 1111 before a two-coat system of Belzona 1341 was applied.

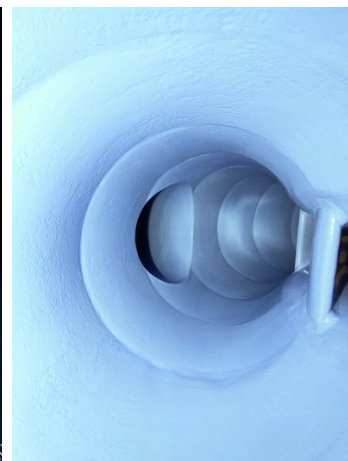
Two coats of Belzona 1341 (Supermetalglide) was applied to Spiral casing.
