Belzona 1341 refurbishes a spiral casing on a Francis turbine

Customer Location: Wales
Application Date: June 2024

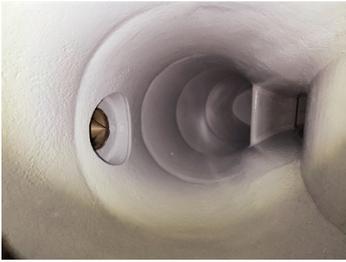
Belzona protective coating from around 2006 was due for a refurbishment

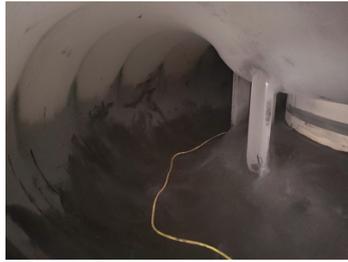
Spiral casing was grit blasted back to profile, using 2.5 tons of grit.

The project involved working in confined spaces with limited access, using 2.5 tons of grit to remove the old lining and achieve the correct profile and cleanliness.

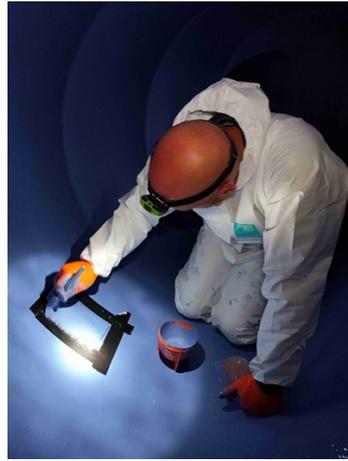
Belzona 1111 was used to reprofile heavily pitted areas prior to coating of Belzona 1341 (Supermetalglide)

Reprofiling was conducted on heavily corroded areas using Belzona 1111 before a two-coat system of Belzona 1341 was applied.

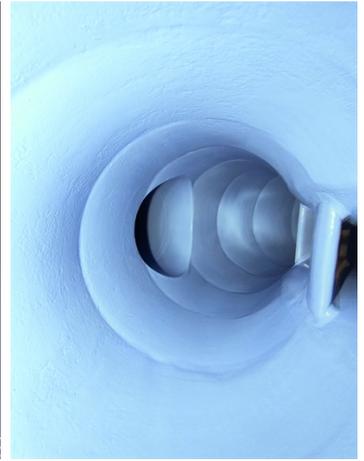
Two coats of Belzona 1341 (Supermetalglide) was applied to Spiral casing.
