Belzona 1321 Solves Cooling Tower Hot Water Basin Seams Leak

ID: 9465

Industry: Power
Application: FPA-Floor Problem Areas
Substrate: Concrete
Products: Belzona 3121 (MR7)

Customer Location: Birmingham, AL
Application Date: December 2023

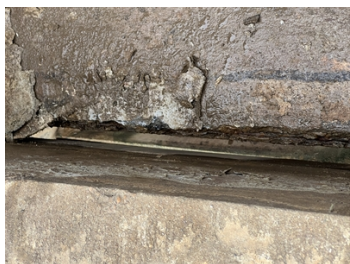
Our client was experiencing multiple leaks from seams on these concrete 4 sided water basins (pools) on top of a large cooling tower.

Current Gaps and Damage to Basin Seams

We first cleaned the existing joints and removed peeling material or debris. We proceeded to fill in gap areas with backer rod when needed and then applied a concrete material. (Belzona 4111 was overbudget in this case.)

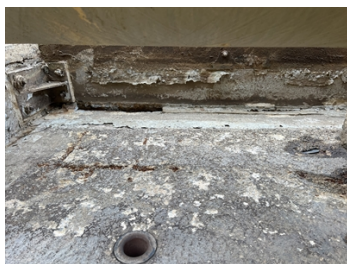
Worn out seams on basins

Our client had experienced leaks with his cooling tower water basins. They were very old and due for a sealing to keep them from leaking. Belzona offered a solution of using 3121 and cloth to reinforce these seams.

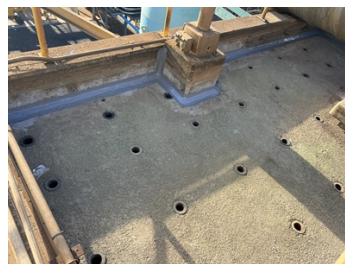
Belzona 3121 Applied with Reinforcement Cloth

We then applied 1 layer of 3121 and laid the reinforcement cloth engrained followed by a second coat of 1321.

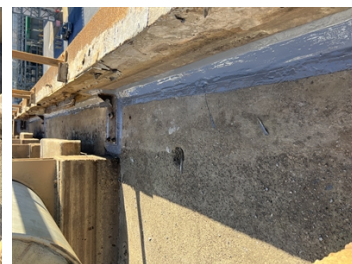
Belzona 3121 Completed

Our customer had used us before on sealing seams that were leaking elsewhere. He wanted to address the existing water basins and seal them. Belzona 3121 offered a great, flexible, barrier coating to address the leaks.
