Belzona 1321 Solves Cooling Tower Hot Water Basin Seams Leak

ID: 9465

Industry: Power
Application: FPA-Floor Problem Areas
Substrate: Concrete
Products: Belzona 3121 (MR7)

Customer Location: Birmingham, AL
Application Date: December 2023

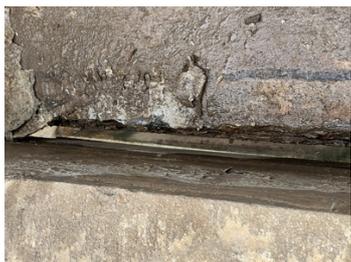
Our client was experiencing multiple leaks from seams on these concrete 4 sided water basins (pools) on top of a large cooling tower.

Current Gaps and Damage to Basin Seams

We first cleaned the existing joints and removed peeling material or debris. We proceeded to fill in gap areas with backer rod when needed and then applied a concrete material. (Belzona 4111 was overbudget in this case.)

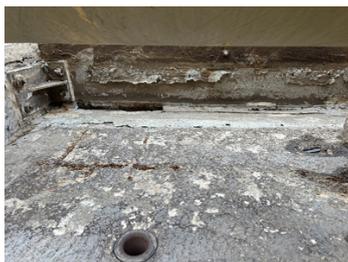
Worn out seams on basins

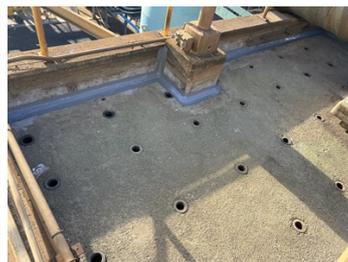
Belzona 3121 Applied with Reinforcement Cloth

We then applied 1 layer of 3121 and laid the reinforcement cloth engrained followed by a second coat of 1321.

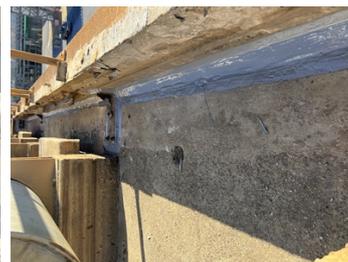
Belzona 3121 Completed
