Belzona 1818/1321 on paper mill pump

ID: 9468

Industry: *Pulp & Paper*
Application: *CEP-Centrifugal Pumps*
Substrate: *Other*
Products: *Belzona 1321 (Ceramic S-Metal), Belzona 1818*

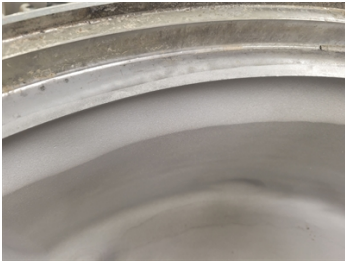
Paper move pump had severe wash out of years of use and needed to be repaired

Damaged pump.

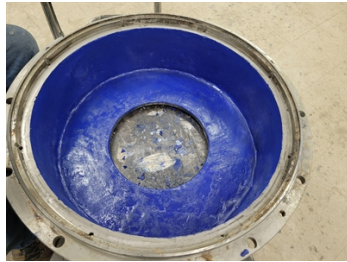
Pump rebuilt with Belzona 1818.

The pump was blasted and cleaned. After cleaning it was rebuilt with Belzona 1818. First coat of Belzona 1321 was applied and shortly after that second coat of Belzona 1321.

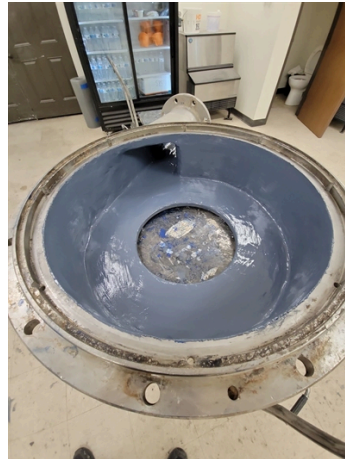
First coating of Belzona 1321.

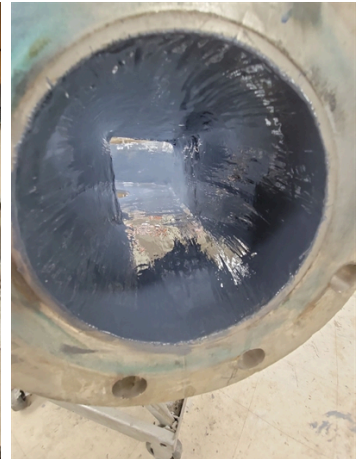
Finished application.
