Belzona 1818/1321 on paper mill pump

ID: 9468

Industry: *Pulp & Paper*
Application: *CEP-Centrifugal Pumps*
Substrate: *Other*
Products: *Belzona 1321 (Ceramic S-Metal), Belzona 1818*

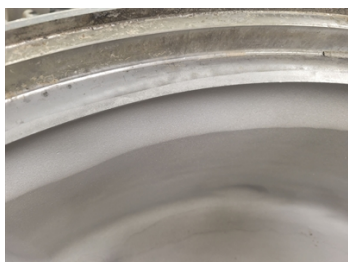
Paper mill pump had severe wash out of years of use and needed to be repaired

Damaged pump.

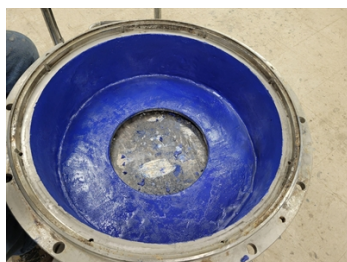
Pump rebuilt with Belzona 1818.

The pump was blasted and cleaned. After cleaning it was rebuilt with 1818. First coat of 1321 was applied and shortly after that second coat of Belzona 1321.

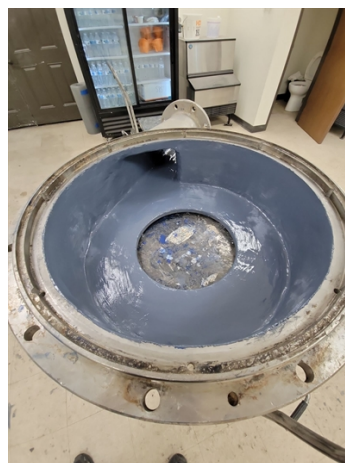
First coating of Belzona 1321.

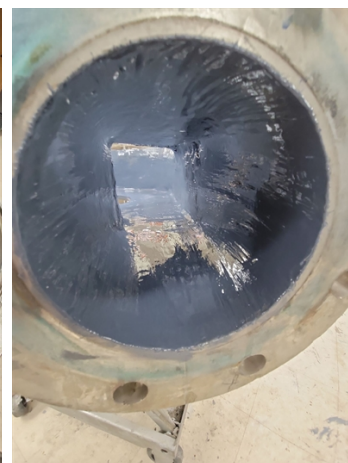
Finished application.
