Belzona 1818/1321 on paper mill pump

ID: 9468

Industry: *Pulp & Paper*
Application: *CEP-Centrifugal Pumps*
Substrate: *Other*
Products: *Belzona 1321 (Ceramic S-Metal), Belzona 1818*

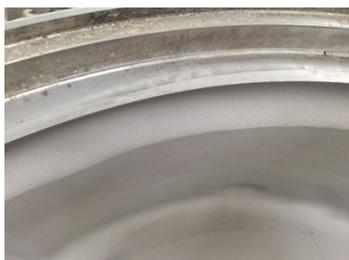
Paper mill pump had severe wash out of years of use and needed to be repaired

Damaged pump.

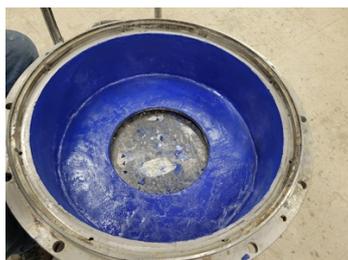
Pump rebuilt with Belzona 1818.

The pump was blasted and cleaned. After cleaning it was rebuilt with Belzona 1818. First coat of Belzona 1321 was applied and shortly after that second coat of Belzona 1321.

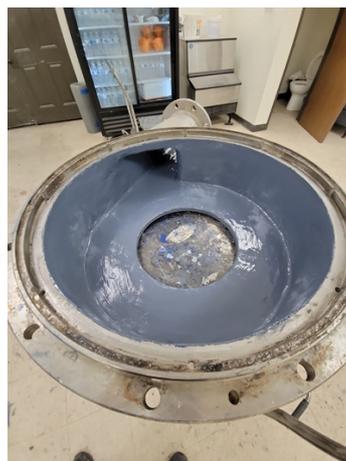
First coating of Belzona 1321.

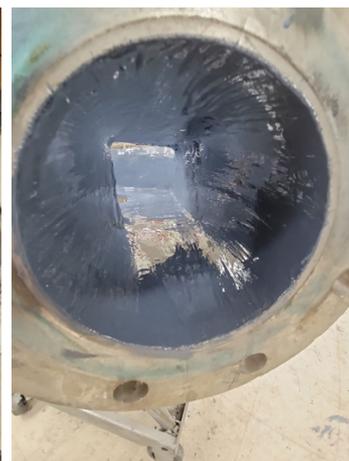
Finished application.
