Stainless Steel Vacuum Pots Seals

ID: 9470

Industry: Chemical & Petrochemical

Application: VPF-Valves, Pipes and Fittings

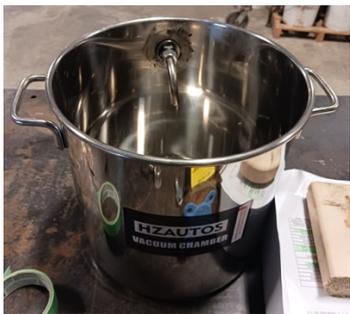
The customer made the purchase of the stainless steel pots and the seal around the fittings started to leak due to the solvents used and was in need of a product that was compatible to be used with hexane, methanol and acetone. Each of these solvents are used at different times during the process.

Stainless-Steel Vacuum Pots

The customer removed the fittings and did the pot wall preparation using a 80 grit sanding discs on a grinder and a wire brush onto the fittings. The Belzona 9111 used to clean and degrease the parts, the Belzona 2911 was used on the S/S and then the Belzona 2311 was mixed and applied to all parts then reinstalled, all nuts had been tightened to make the seal and left to cure.

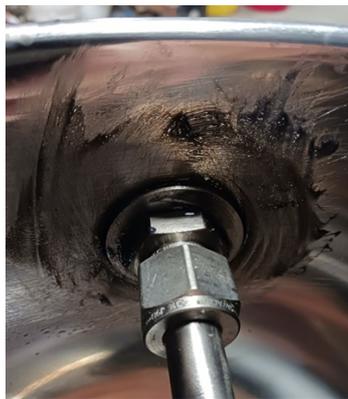
Internal Fitting showing seal of Belzona 2311

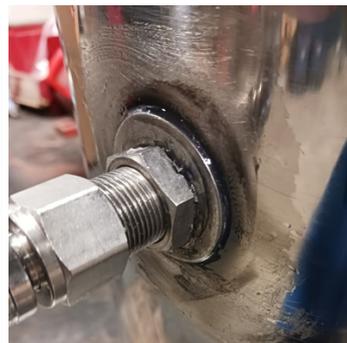
External fitting showing seal of Belzona 2311

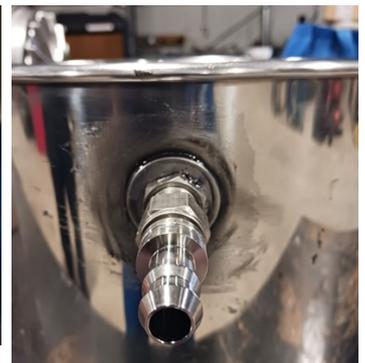
Vacuum pot fitting complete

The customer was very pleased with the performance of the Belzona products and they used the first pot to be sure this was the answer and then moved forward with the repair to the other vacuum pots later, I had made contact with the customer in July 2024 and he insured me that all was working well and the plant was happy with the performance and no leaks around the seal.
