Stainless Steel Vacuum Pots Seals

ID: 9470

Products: Belzona 2311 (SR Elastomer), Belzona 2911 (Elastomer QD Conditioner), Belzona 9111 (Cleaner Degreaser)

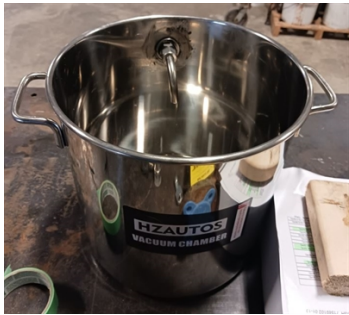
Stainless-Steel Vacuum Pots

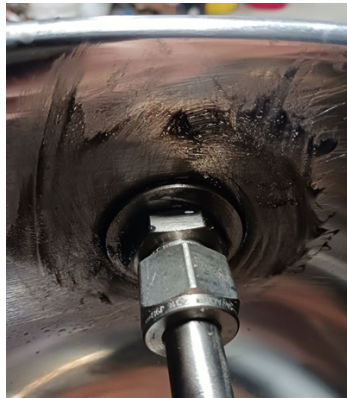
Internal Fitting showing seal of Belzona 2311

The customer removed the fittings and did the pot wall preparation using a 80 grit sanding discs on a grinder and a wire brush onto the fittings. The Belzona 9111 used to clean and degrease the parts, the Belzona 2911 was used on the S/S and then the Belzona 2311 was mixed and applied to all parts then reinstalled, all nuts had been tightened to make the seal and left to cure.

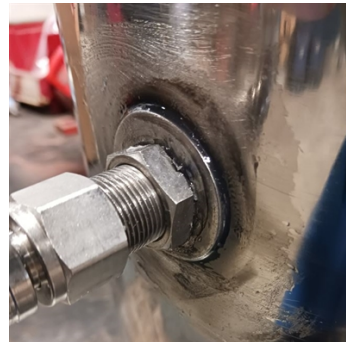
External fitting showing seal of Belzona 2311

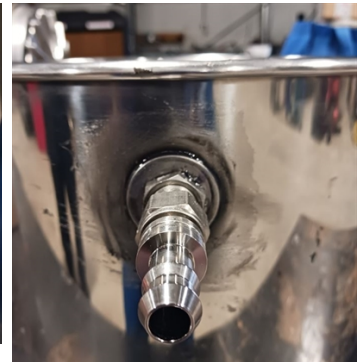
Vacuum pot fitting complete
