# Wind Farm Transformer Repair

ID: 9471

Industry: Power  
Application: TCC-Tanks and Chemical Containment Areas  
Substrate: Carbon steel  
Products: Belzona 1161 (Super UW-Metal), Belzona 5831 (ST-Barrier)

Customer Location: Agios Georgios  
Application Date: June 2024

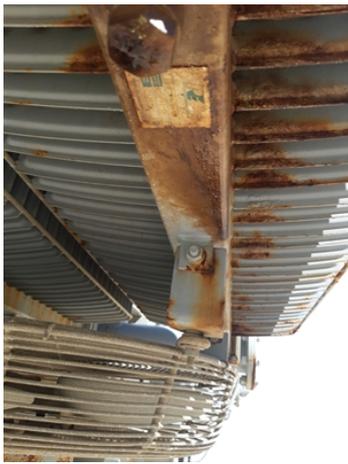
Corrosion and leakage from the cooling channels.

Initial condition illustrating rust and leakage.

Before applying Belzona, the surface was cleaned to get rid of the oil and rust.

Belzona 1161 was used for surface repair in conjunction with Belzona reinforcement sheet 9341.

Belzona 5831 was applied to it for protection following the Belzona 1161 treatment.

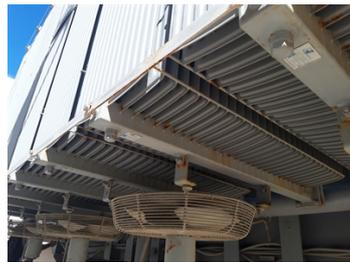
Initial condition illustrating rust.

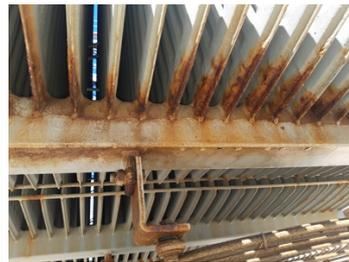
Initial condition illustrating rust and leakage.

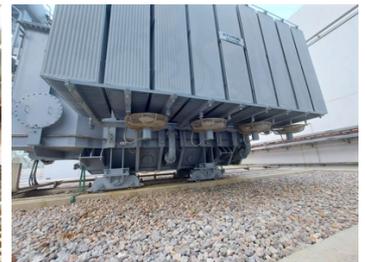
complete application

System Leaflet TCC-1 was followed
