# BELZONA RESTORED THE PROTECTIVE LINING OF CALORIFIER HOT WATER TANK.

ID: 9472

Industry: Heating, Ventilation & Air Conditioning  
Application: TCC-Tanks and Chemical Containment Areas  
Substrate: Carbon steel  
Products: Belzona 5892

Customer Location: HAMAD PORT, DOHA QATAR  
Application Date: June 2024

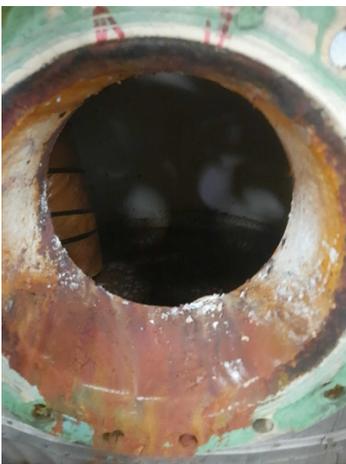
General corrosion which creates uniform pitting on the upper part of the tank.

Appearance before blasting

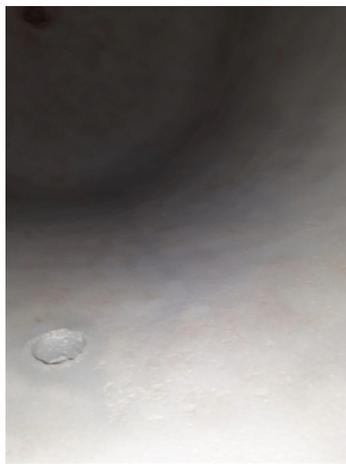
After surface preparation by grit blasting

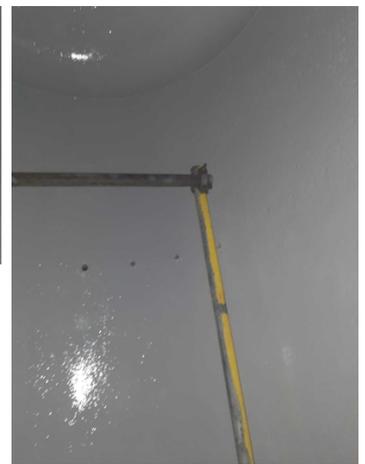
After final coat completed
