# BELZONA RESTORED THE PROTECTIVE LINING OF CALORIFIER HOT WATER TANK.

ID: 9472

Industry: Heating, Ventilation & Air Conditioning  
Application: TCC-Tanks and Chemical Containment Areas  
Substrate: Carbon steel  
Products: Belzona 5892

Customer Location: HAMAD PORT, DOHA QATAR  
Application Date: June 2024

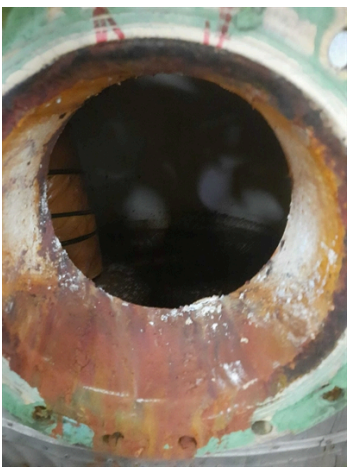
General corrosion which creates uniform pitting on the upper part of the tank.  
The Operating Temperature is from 80 to 95 deg. C and the relevant advice is to apply High Temperature Protective Coating.

Appearance before blasting

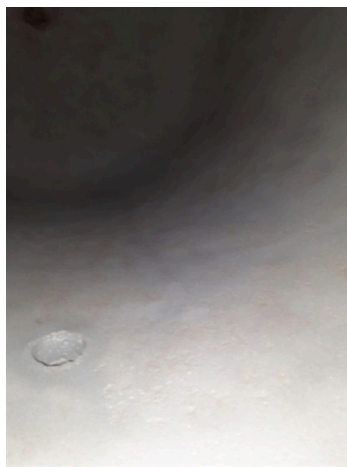
After surface preparation by grit blasting

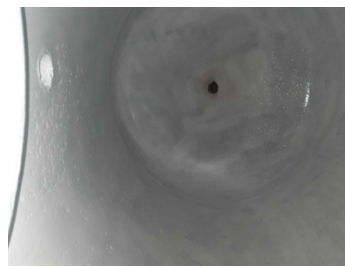
After first coating completed

Application was done using stiff bristled brush only.  
The application was done in accordance with System Leaflet TCC-03

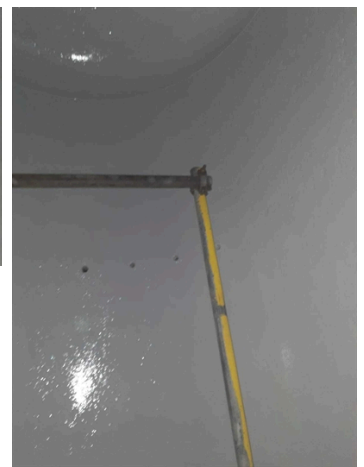
After final coat completed
