BELZONA RESTORED THE ERODED TRANSPORT VESSEL TAIL PIPE

ID: 9473

Industry: *Marine*
 Application: *SOS-Ships and Offshore Structures*

Substrate: *Aluminum*
 Products: *Belzona 1311 (Ceramic R-Metal), Belzona 1321 (Ceramic S-Metal)*

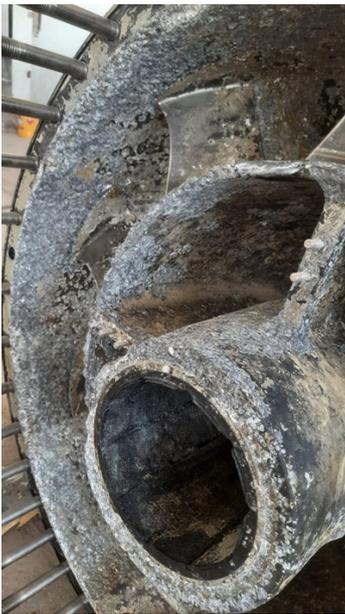
Corrosion-erosion damaged lower half of the tail pipe due to stationary submerged in seawater for 3 years.

BEFORE SURFACE PREPARATION SHOWING THE EXTENT OF DAMAGE DUE TO METALLIC EROSION.

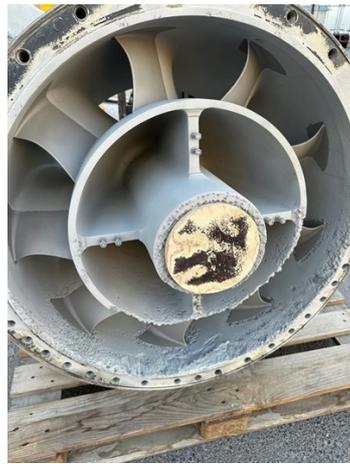
AFTER SURFACE PREPARATION BY GRIT BLASTING EXPOSING DEEP PITTING AND METAL LOSS.
