BELZONA RESTORED THE ERODED TRANSPORT VESSEL TAIL PIPE

ID: 9473

Industry: Marine
Application: SOS-Ships and Offshore Structures

Substrate: Aluminum
Products: Belzona 1311 (Ceramic R-Metal), Belzona 1321 (Ceramic S-Metal)

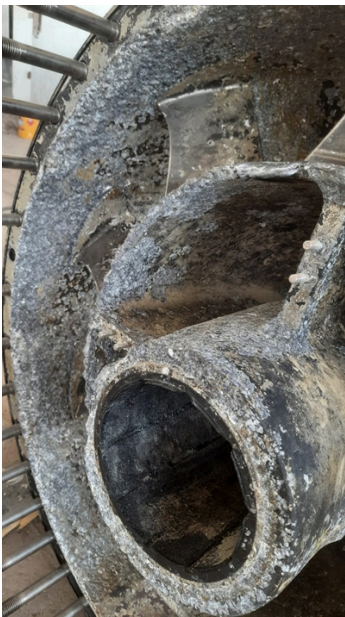
Corrosion-erosion damaged lower half of the tail pipe due to stationary submerged in seawater for 3 years.

BEFORE SURFACE PREPARATION SHOWING THE EXTENT OF DAMAGE DUE TO METALLIC EROSION.

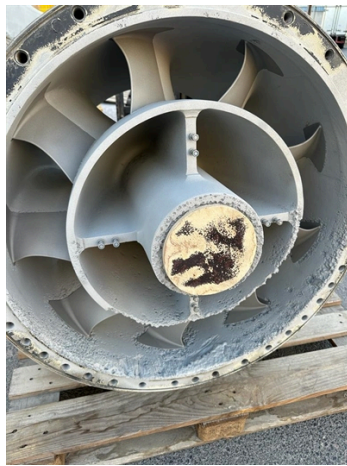
AFTER SURFACE PREPARATION BY GRIT BLASTING EXPOSING DEEP PITTING AND METAL LOSS.

Severe corrosion pitting on lower half of the Tail Pipe which needs to be rebuilt to restore the original state and requires ceramic protective coating for future prevention against erosion attack.

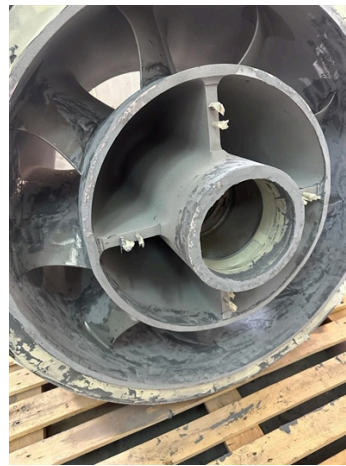
ALL DAMAGED AREA WAS REBUILT USING BELZONA 1311.

Manual application using stiff bristle brush and provided plastic applicator to rebuild the eroded areas and to apply protective ceramic coating.

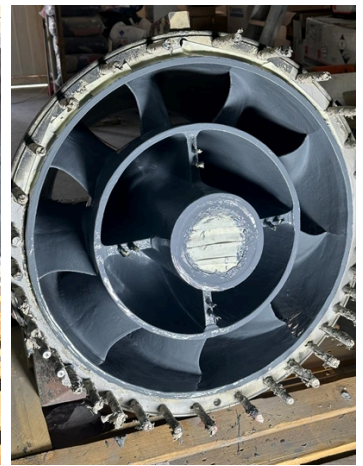
COMPLETED APPLICATION.

One year after the application, the client provided feedback that the equipment is still in good working condition.
