# BELZONA STRESS CRACK LEAK SEALING AND PLATE BONDING ON EXTERNAL SURFACE OF CRUDE OIL EXPORT PUMP.

ID: 9474

Application: CEP-Centrifugal Pumps

Application Date: June 2022

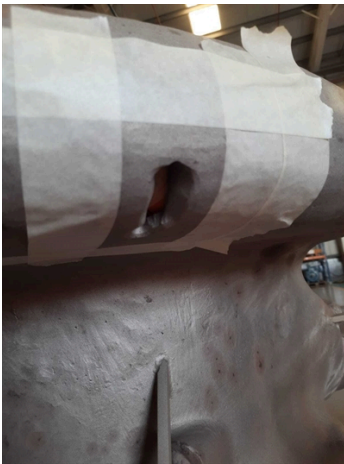
The pump is suffering from leakage due to a combination of tensile stress and a corrosive environment which is the chloride content of the medium.

Leak due to stressed crack line which requires a crack sealing technique and plate bonding.

WIDENED CRACK LINE DRILLED ON BOTH ENDS.

The crack has to be sealed externally due to insufficient or limited access on internal area of the pump.

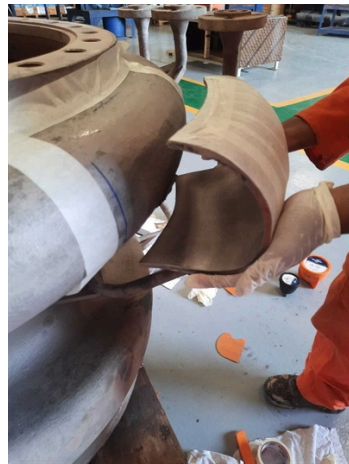
DRY FITTING OF THE PLATE PRIOR TO HOLE SEALING AND PLATE BONDING

A fabricated plate which is curved according to the groove of the external profile of the pump plate was prepared to completely cover the whole affected area.

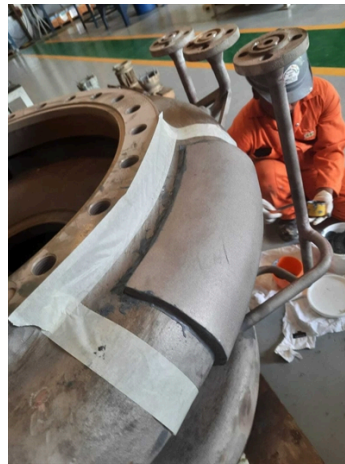
COMPLETED PLATE BONDING USING BELZONA 1311

Application was done using stiff bristled brush by manual application. Plate bonding was recommended to build additional wall thickness on the affected part of the pump.

The Application was done in accordance with Belzona System Leaflet CEP-06

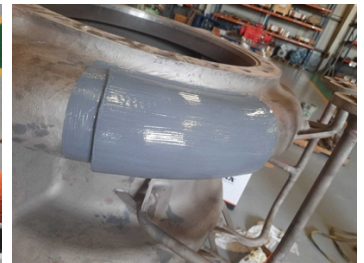
TOP COATING COMPLETED FOR FOR THE BONDED PLATE PROTECTION.

Belzona Ceramic Rebuilding and Coating Grade has a high resistance against erosion-corrosion. Solution provided was accepted and approved by client instead replacing the whole pump. According to the client's feedback, after putting the pump back in service

offshore, the equipment continues to perform well in operation.
