BELZONA STRESS CRACK LEAK SEALING AND PLATE BONDING ON EXTERNAL SURFACE OF CRUDE OIL EXPORT PUMP.

ID: 9474

Industry: Oil & Gas
 Application: CEP-Centrifugal Pumps
 Substrate: Stainless-steel
 Products: Belzona 1311 (Ceramic R-Metal), Belzona 1321 (Ceramic S-Metal)

Customer Location: RAS LAFFAN, QATAR
 Application Date: June 2022

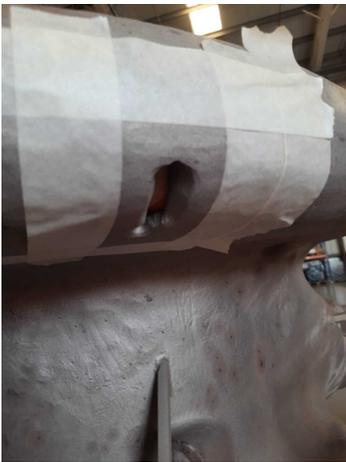
WIDENED CRACK LINE DRILLED ON BOTH ENDS.

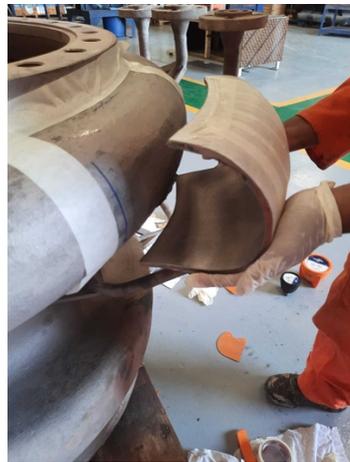
DRY FITTING OF THE PLATE PRIOR TO HOLE SEALING AND PLATE BONDING

A fabricated plate which is curved according to the groove of the external profile of the pump plate was prepared to completely cover the whole affected area.

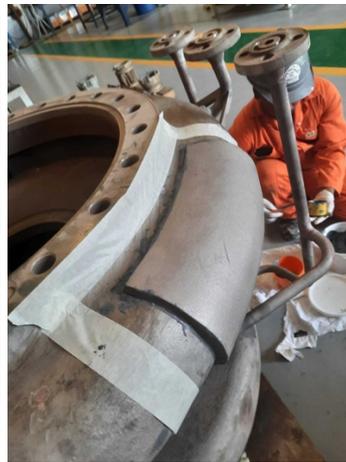
COMPLETED PLATE BONDING USING BELZONA 1311

Application was done using stiff bristled brush by manual application. Plate bonding was recommended to build additional wall thickness on the affected part of the pump.

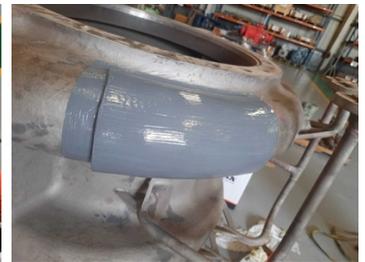
TOP COATING COMPLETED FOR FOR THE BONDED PLATE PROTECTION.
