BELZONA STRESS CRACK LEAK SEALING AND PLATE BONDING ON EXTERNAL SURFACE OF CRUDE OIL EXPORT PUMP.

ID: 9474

Application: CEP-Centrifugal Pumps

Substrate: Stainless-steel

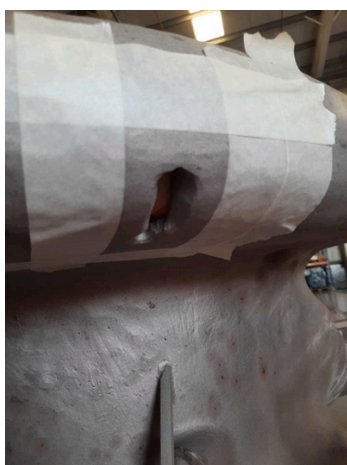
WIDENED CRACK LINE DRILLED ON BOTH ENDS.

The pump is suffering from leakage due to a combination of tensile stress and a corrosive environment which is the chloride content of the medium.

Leak due to stressed crack line which requires a crack sealing technique and plate bonding.

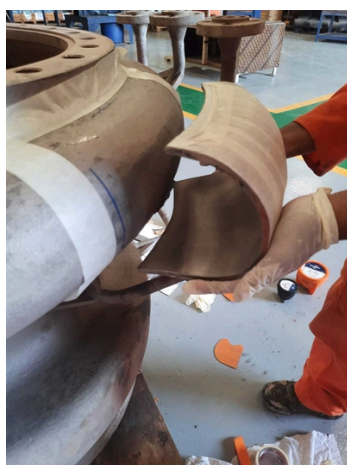
DRY FITTING OF THE PLATE PRIOR TO HOLE SEALING AND PLATE BONDING

A fabricated plate which is curved according to the groove of the external profile of the pump plate was prepared to completely cover the whole affected area.

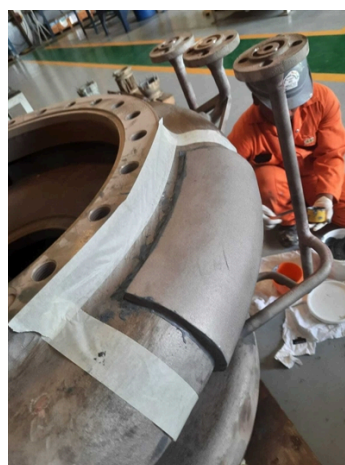
COMPLETED PLATE BONDING USING BELZONA 1311

Application was done using stiff bristled brush by manual application. Plate bonding was recommended to build additional wall thickness on the affected part of the pump.

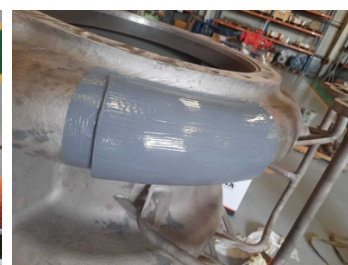
TOP COATING COMPLETED FOR FOR THE BONDED PLATE PROTECTION.
