Office roof 5 years of protection

Application: RPA-Roof Problem Areas

Issues on the main office block roof of a chemical production and blending facility were allowing rainwater to leak into the main offices and boardroom below.

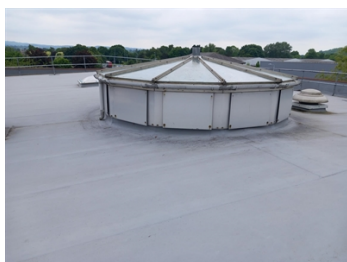
Showing no deterioration to applied Belzona 3131 coating

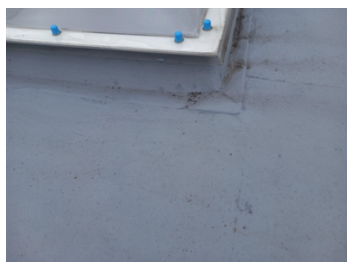
Awkward geometry catered for easily with the Belzona 3131 coating

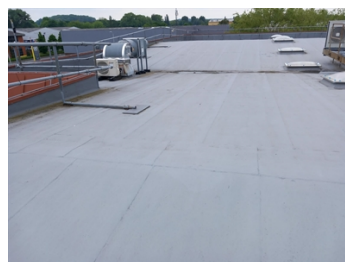
A larger expanse of the main roof where the Belzona 3131 was applied
