Office roof 5 years of protection

Industry: Chemical & Petrochemical
Application: RPA-Roof Problem Areas
Substrate: Other
Products: Belzona 3131 (WG Membrane), Belzona 3921 (GSC Surface Conditioner), Belzona 3931 (WG Membrane Conditioner)

Customer Location: Loughborough

Application Date: January 2019

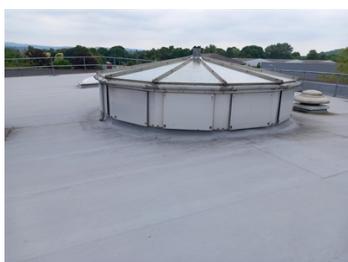
Showing no deterioration to applied Belzona 3131 coating

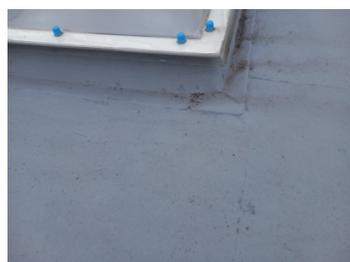
Awkward geometry catered for easily with the Belzona 3131 coating

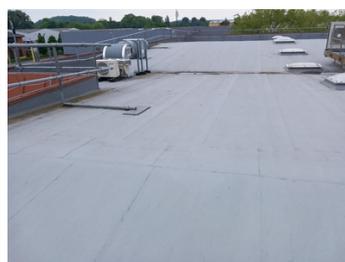
A larger expanse of the main roof where the Belzona 3131 was applied

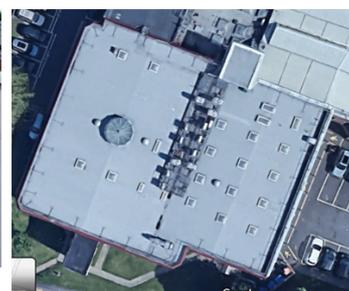
An aerial view of the roof showing a fabulous uniform finish, still looking good after 5 years

obvious issue, but the Belzona 3131 Winter Grade performed brilliantly and is still showing no signs of deterioration 5 years later
