Kingspan Joint sealing

Industry: Food & Drink
Application: RPA-Roof Problem Areas
Substrate: Carbon steel
Products: Belzona 2211 (MP Hi-Build Elastomer), Belzona 2911 (Elastomer QD Conditioner), Belzona 9111 (Cleaner Degreaser)

Customer Location: Thorne
Application Date: May 2024

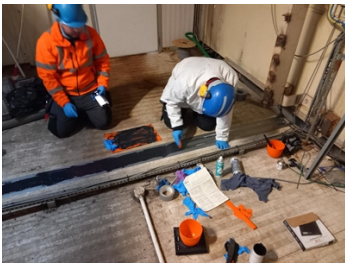
Condensation from local chillers were forming puddles and a build up of standing water over the Kingspan roof sheets of a large chiller room. The water would stand, then penetrate the joints, leaking into the chiller itself, where moving aerial conveyor hooks transported the food product below. The joints needed to be sealed so a trial was sought

Setting out the works

Access was gained to the roof space above the chiller

The target area was prepared by grinding in a cross hatch pattern to gain best effort preparation to the steel kingspan sheets

The area was degreased and cleaned using Belzona 9111

Masking tape was used to gain clean lines on the finished application

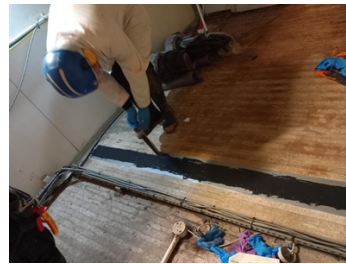
Finishing off the application

Removing masking

Belzona 2211 was mixed and the Kingspan joint was wetted out, as was the Belzona 9431 reinforcing sheet which was applied over the wetted out Kingspan

Belzona 2211 was applied using a Belzona applicator to complete the works

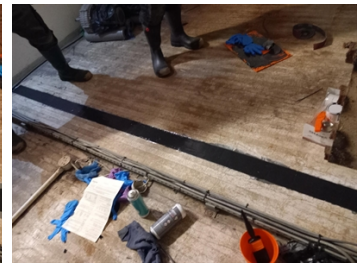
Masking removed showing the completed works

The masking was removed immediately
