# Blast Enclosure given longer life

**Industry:** General Industry  
**Application:** TCC-Tanks and Chemical Containment Areas  
**Substrate:** Carbon steel  
**Products:** Belzona 1321 (Ceramic S-Metal), Belzona 9111 (Cleaner Degreaser)

**Customer Location:** Peterborough  
**Application Date:** June 2024

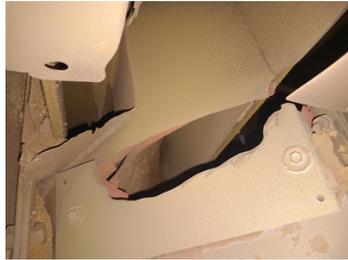
Internal view showing the totally worn away side plates where debris, dust and blast media can escape

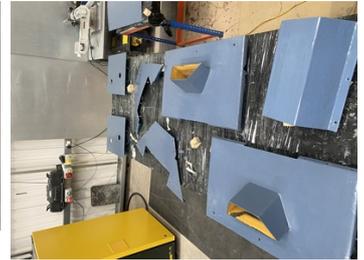
New plates, provided by the customer, were blast cleaned to Belzona 1321 prep spec

New steel parts were delivered to Belzona UK in Hawarden  
The plates were grit blasted to the IFU specs of the Belzona 1321 product  
2 coats (of different colours) of Belzona 1321 were applied to the blasted steel in line with the Belzona 1321 IFU  
Transport was arranged by Belzona to return the plates to site
