Blast Enclosure given longer life

ID: 9477

Industry:	General Industry	Customer Location:	Peterborough
Application:	TCC-Tanks and Chemical Containment Areas	Application Date:	June 2024
Substrate:	Carbon steel		
Products:	Belzona 1321 (Ceramic S-Metal), Belzona 9111 (Cleaner Degreaser)

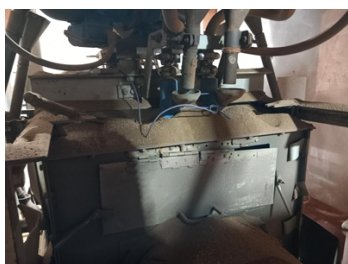
External of the blast enclosure in situ

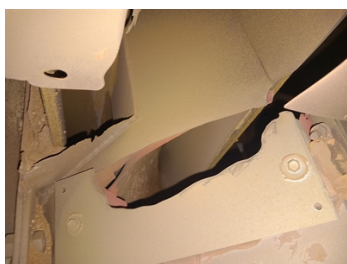
The steel wall plates of the blast enclosure were naturally wearing away by the internal blasting process. This would lead to through-wall and escaping blast media and dust. Eventually the line would have to be stopped and the plates replaced, causing downtime and manpower resource requirements. There was also a cost issue with continually buying new parts

Internal view showing the totally worn away side plates where debris, dust and blast media can escape

The wearing away of the plates were causing the engineers many issues, including a serious Health and Safety risk from flying debris. It was decided to apply two coats of Belzona 1321 Ceramic S metal and have the asset checked at regular intervals. This was with a view to looking out for the base colour showing through the second layer, whereby the engineers on site had agreed to prep up the worn areas and overcoat with more of the second layer, thereby allowing the engineers a visual indicator and a window of opportunity to continually re-treat the most affected areas and save having to take the enclosure apart to rebuild it with new.

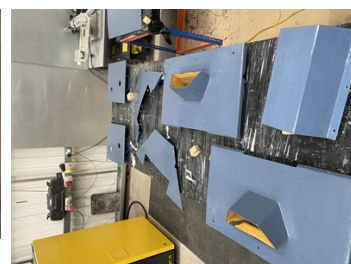
Showing the plates following the application of 2 x colours of Belzona 1321 Ceramic S Metal

2 coats (of different colours) of Belzona 1321 were applied to the blasted steel in line with the Belzona 1321 IFU
