BELZONA REPLACES THE DAMAGED COATING OF BRP PUMP

ID: 9479

Industry: Power
Application: CEP-Centrifugal Pumps
Substrate: Carbon steel
Products: Belzona 5821

Customer Location: RAS LAFFAN QATAR
Application Date: January 2023

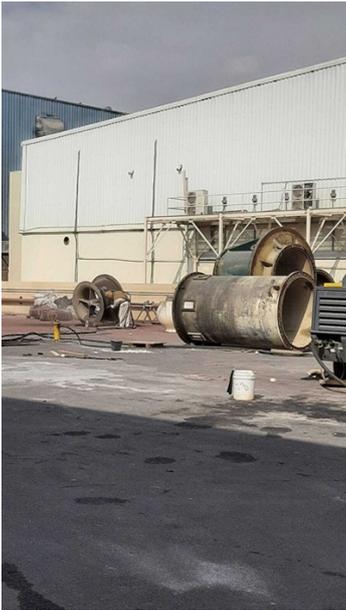
BRP pump status before surface preparation

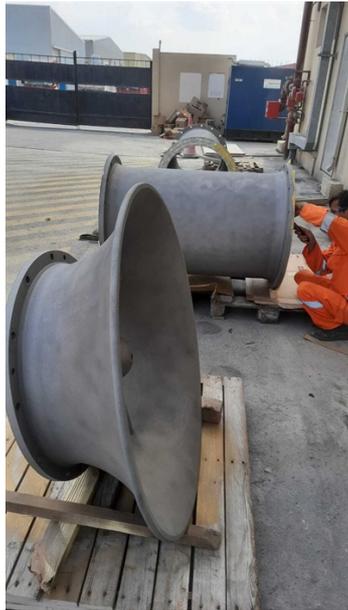
After surface preparation using grit blasting

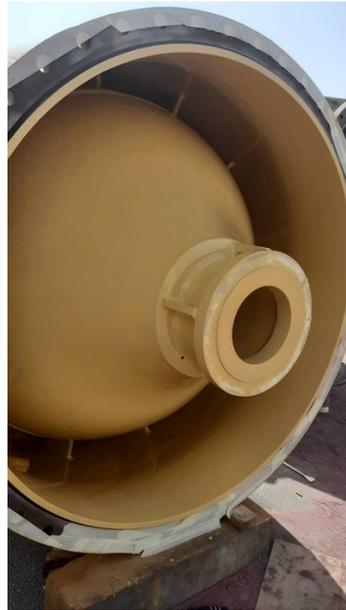
Application of first and second coat was completed and in this is the completed third coat application.

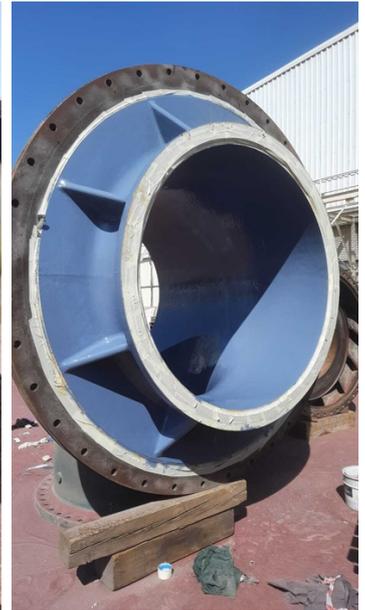
fourth and final coat completed

The application was done in 4 coat system due to clients coating thickness requirement is to achieve minimum 600 microns. Application carried out using only 3 inches stiff bristle brush. Application was done in accordance with product System Leaflet CEP-03
