BELZONA REPLACES THE DAMAGED COATING OF BRP PUMP

ID: 9479

Industry: Power
Application: CEP-Centrifugal Pumps
Substrate: Carbon steel
Products: Belzona 5821

Customer Location: RAS LAFFAN QATAR
Application Date: January 2023

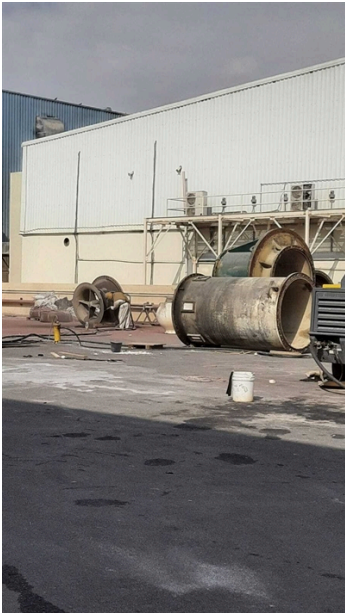
The BRP (Brine Recirculating Pump) was suffering from scattered corrosion due to damage on the existing coating.

BRP pump status before surface preparation

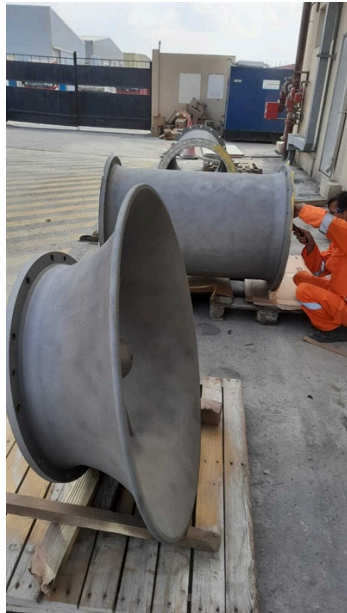
After surface preparation using grit blasting

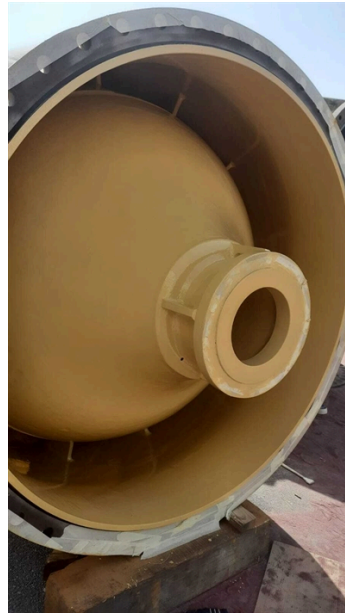
Application of first and second coat was completed and in this is the completed third coat application.

The application was done in 4 coat system due to clients coating thickness requirement is to achieve minimum 600 microns. Application carried out using only 3 inches stiff bristle brush. Application was done in accordance with product System Leaflet CEP-03

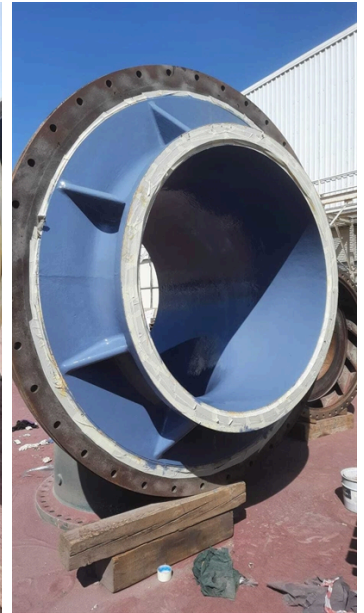
fourth and final coat completed
