# Belzona Protects The Separator From Abrasion

Industry: Cement

Application: SHM-Solids Handling Machinery

Sichter separator in cement plant.

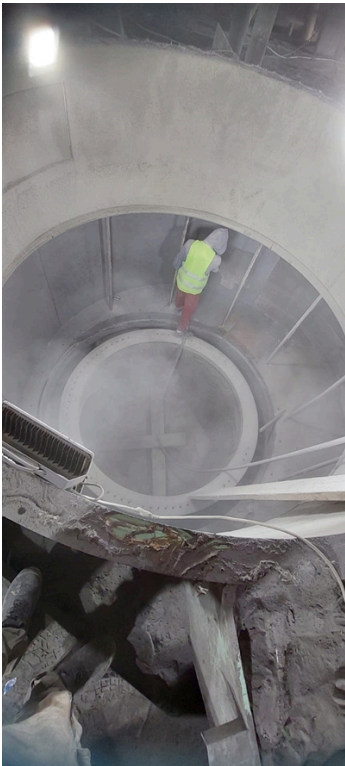
After Blasting

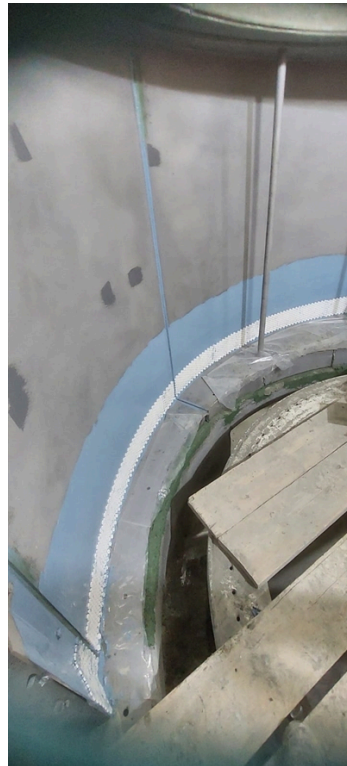
Rebuilding the pitted areas using Belzona 1311 and then applying Belzona 1391T as an adhesive to bond Belzona 9811 Almina Tiles

Applying Belzona 9811 Almina Tiles with Belzona 1391T as the adhesive

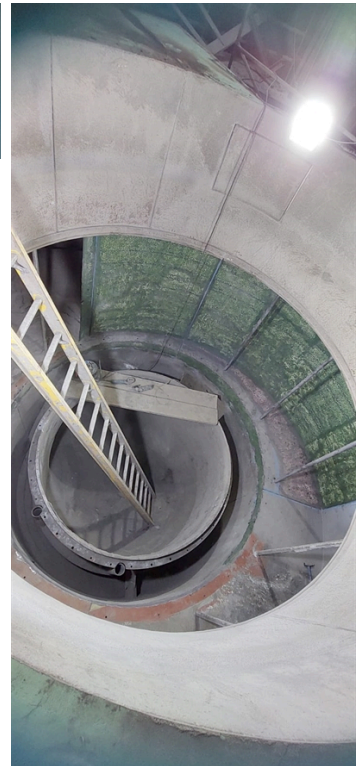
Application completed after applying Belzona 9811 then grouted with Belzona 1813
