Belzona Protects The Separator From Abrasion

Application: SHM-Solids Handling Machinery

Sichter separator in cement plant.

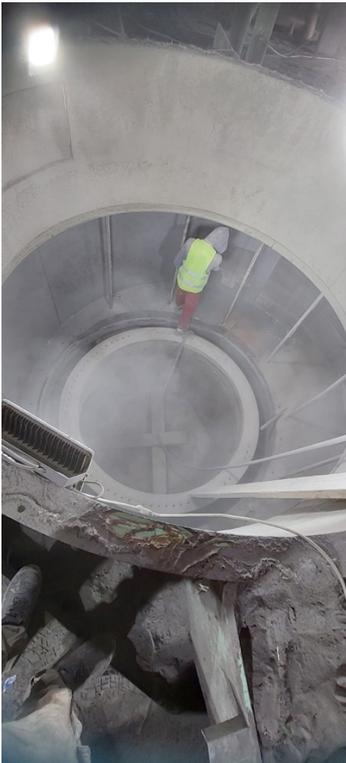
The shell of separator suffers from severe abrasion and structural defects in that section would cause safety and operational problems.

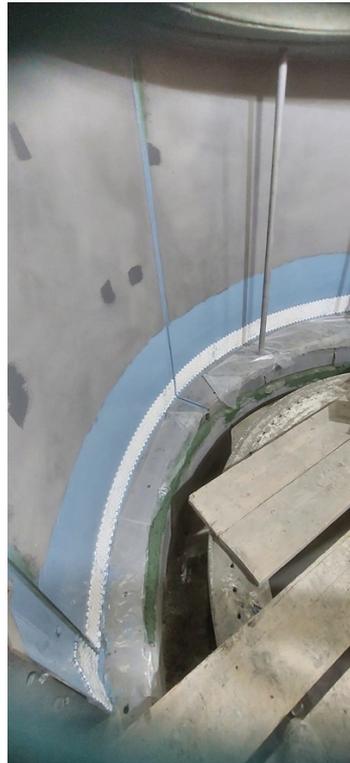
After Blasting

Rebuilding the pitted areas using Belzona 1311 and then applying Belzona 1391T as an adhesive to bond Belzona 9811 Almina Tiles

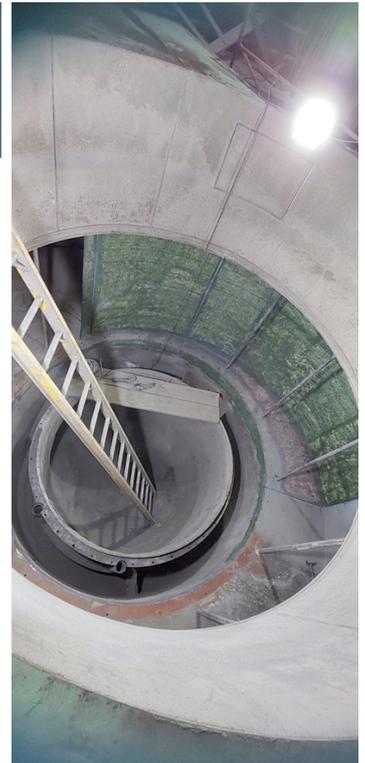
Application completed after applying Belzona 9811 then grouted with Belzona 1813

Applying Belzona 9811 Almina Tiles with Belzona 1391T as the adhesive
