BELZONA ELASTOMER REPAIRS DAMAGED RUBBER LINING OF SEAWATER LINE FILTER

ID: 9483

Customer Location: MESAEED, QATAR
Application Date: July 2024

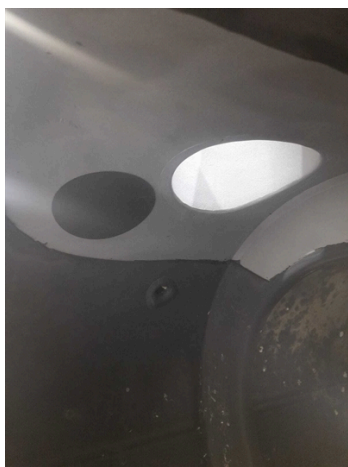
After surface preparation AND DURING SALT CONTAMINATION TEST

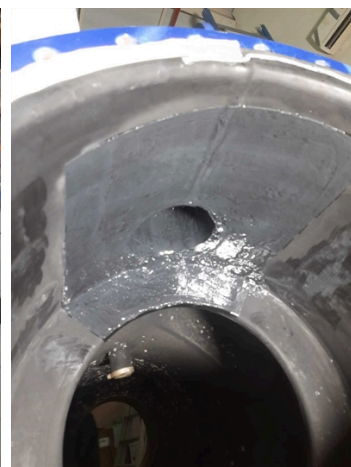
RUBBER LINING REPAIR COMPLETED

The application was done using a stiff bristle brush, provided plastic applicator, fabricated flange face former and a fabricated metal using Belzona 2921 as the surface conditioner and Belzona 2211 as the rebuilding material. The application was done in accordance with Belzona System Leaflet VPF-03 and VPF-17
