# BELZONA ELASTOMER REPAIRS DAMAGED RUBBER LINING OF SEAWATER LINE FILTER

ID: 9483

Customer Location: MESAEED, QATAR  
Application Date: July 2024

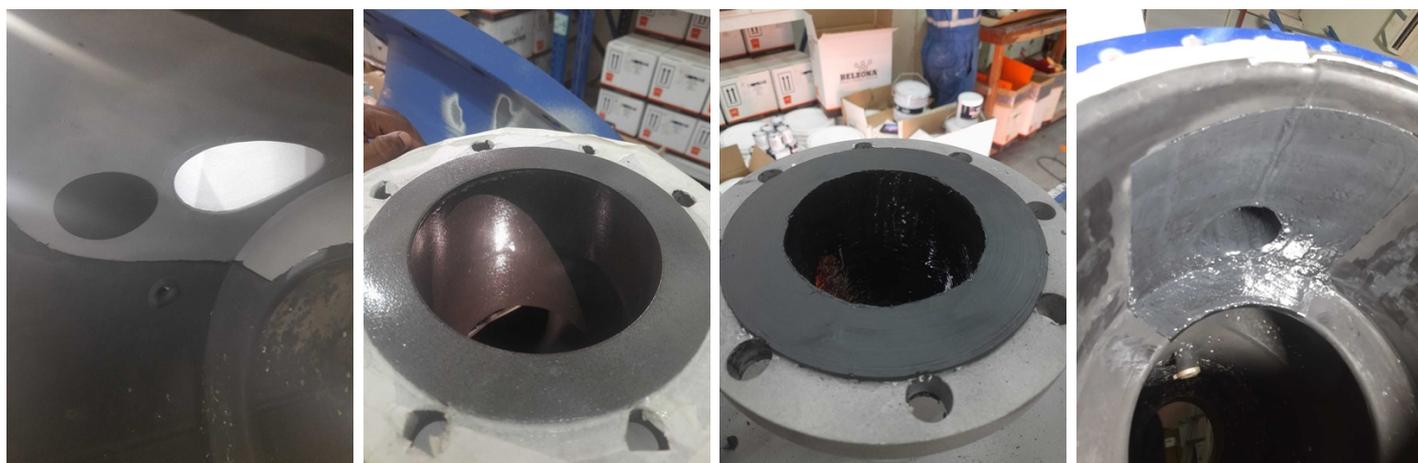
Damaged existing rubber lining, the metal shell was punctured due to liquid medium contact to metal which create pinholes on the nozzle welding joint.

After surface preparation AND DURING SALT CONTAMINATION TEST

COMPLETED SURFACE CONDITIONER APPLICATION.

COMPLETED FLANGE FACE FORMING USING FLANGE FACE FORMER.

RUBBER LINING REPAIR COMPLETED

The rubber lining was detached starting from inner surface of the pipe up to the connected nozzle flange face. The nozzle size is 6 inches, a metal former was fabricated to maintain the required 5mm thickness inside the nozzle surface. Flange Face Forming is required on the worn out rubber lining of the flange face.

The application was done using a stiff bristle brush, provided plastic applicator, fabricated flange face former and a fabricated metal using Belzona 2921 as the surface conditioner and Belzona 2211 as the rebuilding material. The application was done in accordance with Belzona System Leaflet VPF-03 and VPF-17
